Bulletin No.: 17-NA-004

# Service Bulletin

**Subject:** High Opening Efforts on Outside Door Handle

| Brand: | Model: | Model Year: | | VIN: | | Engine: | Transmission: |
|---|---|---|---|---|---|---|---|
| Chevrolet | Camaro | 2016 | 2017 | | | All | All |

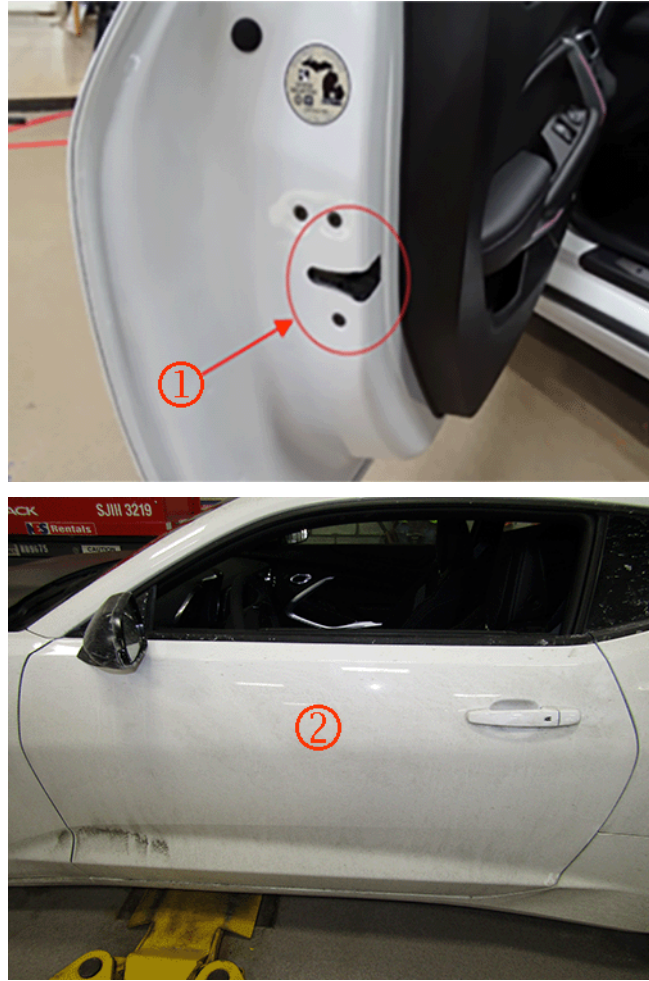
The cause of the condition may be that due to a lack of an outboard weatherstrip on the door, the door latch (1) may be prone to excessive dust intrusion and higher resistance. The condition is usually more evident in extreme dry, dusty conditions (2).

Wipe clean and apply GM Super Lube® lubricant to both door latches following the Service Procedure below.
