# Service Bulletin

**Subject:** Repeated Radio/display Resets, Volume Control Inoperative, Waiting for Update Media Message, Voice Command For Calling Bluetooth Phone Contacts Inoperative, Service Rear Vision System Message, Radio Turns On Unwanted At Startup, and/or Navigation Radio Destination State Defaults To WV

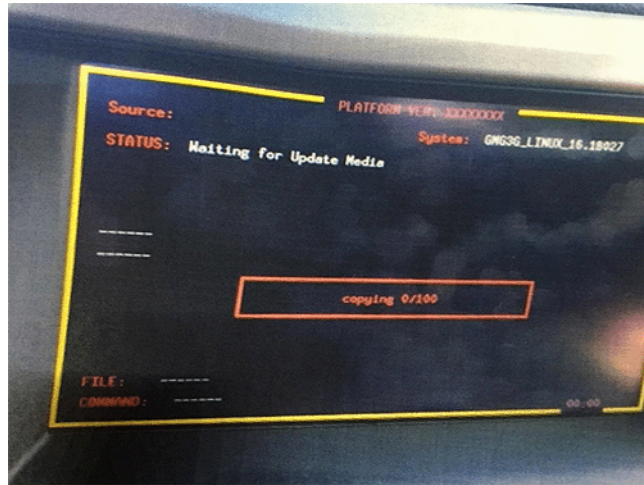
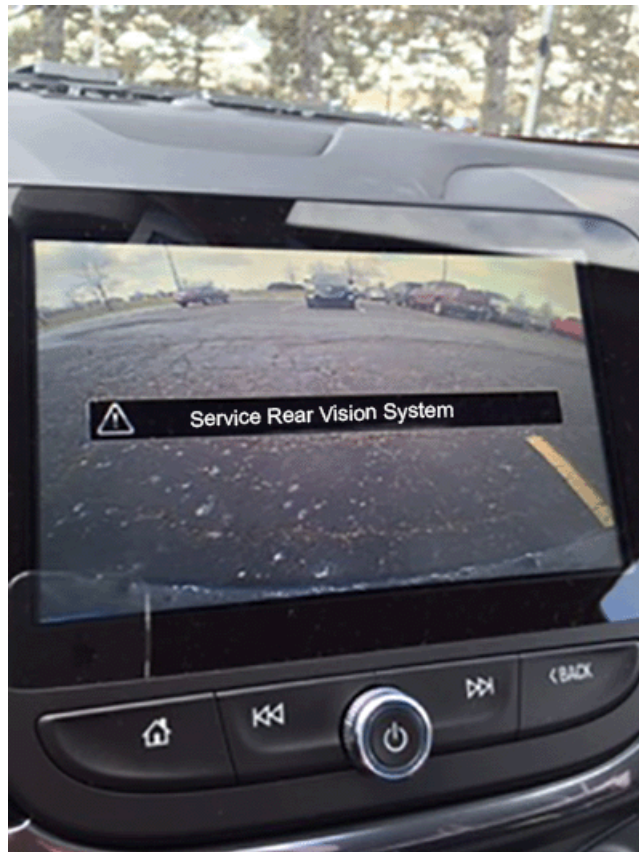
- Random Infotainment system display resets while driving, screen temporarily goes blank and then returns after approximately 5 seconds.
- The “waiting for update media” screen appears/appeared while driving and may disappear after 80 minutes.
- The volume knob or slider bar (Cadillac) will not function.
- Momentary black screen at start up.
- Voice recognition inoperative for Calling Bluetooth Phone Contacts.
- Seek buttons on the front controls will not function.
- XM only shows radio ID. Station List is blank.
- Radio will shut off and when restarting the vehicle the radio will turn on unwanted.

- Service Rear Vision System Message displayed.

<ul style="list-style-type: none"> <li>• Service Rear Vision System Message displayed.</li> <li>• When entering an address using the touch screen the state selection defaults to West Virginia (WV) instead of Virginia (VA).</li> </ul> <p><b>Note:</b> This software update also includes CarPlay and Android Auto Improvements.</p>
<b>Cause</b>	This may be due to a software anomaly.
