Service Bulletin

Subject: Malfunction Indicator Lamp (MIL) Illuminated - DTCs P2797 and/or P2798 Set

Brand:	Model:	Model Year:		VIN:		Engine:	Transmission:
		from	to	from	to		
Chevrolet	Bolt EV	2017	2017				
Opel	Ampera-e	2017	2017

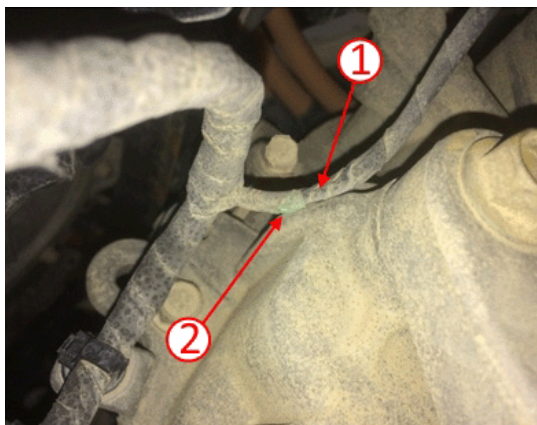
6. Inspect the wiring harness (1) for signs of contact or damage (2).

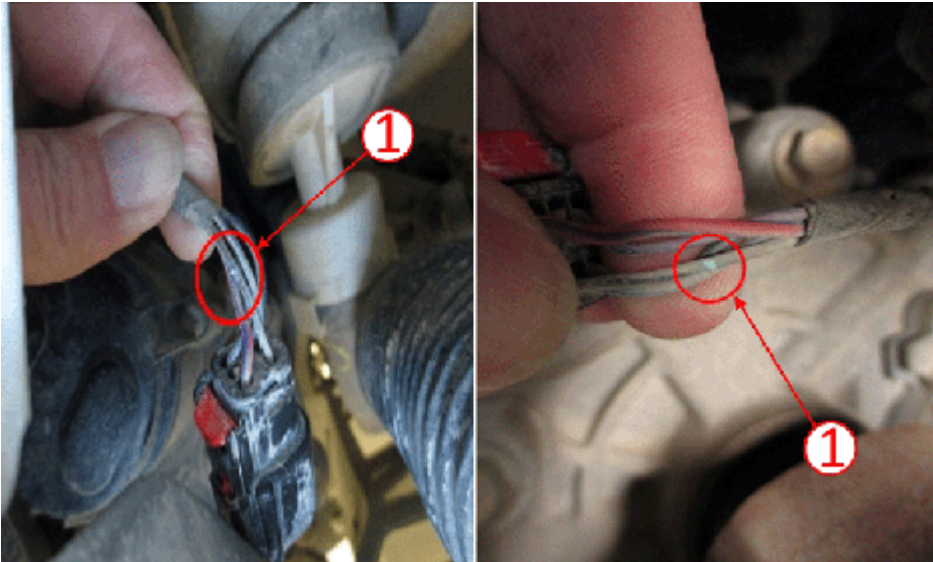
7. Inspect the harness for any signs of open cuts and/or corrosion in the insulator (1).
8. Repair the wiring harness as needed. Refer to *Wire-to-Wire Repair* in SI.
9. Using Woven Polyester Electrical Tape (PET), tape the harness ensuring that the tape is applied in a double layer extending along the harness past the contact points.
