Service Bulletin

Subject: Hood Flutter, Shake or Vibration at Highway Speeds or over Rough Road Conditions

Brand:	Model:	Model Year:		VIN:		Engine:	Transmission:
		from	to	from	to		
Buick	Envision	2016	2017			All	All

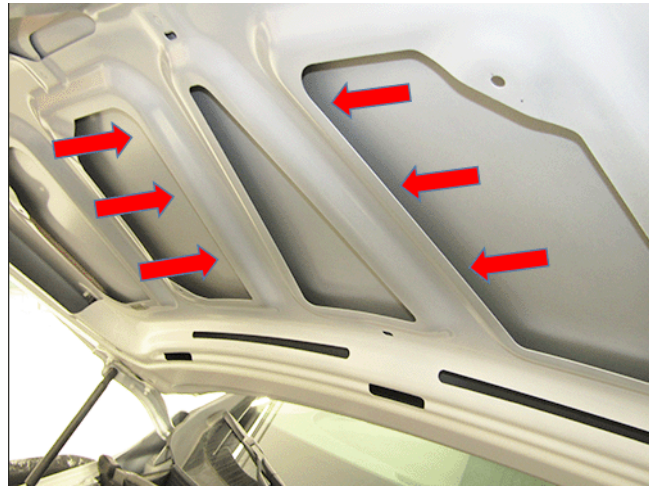
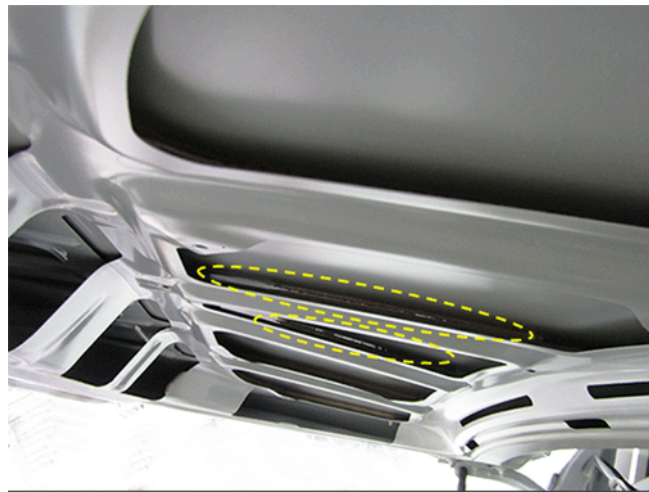
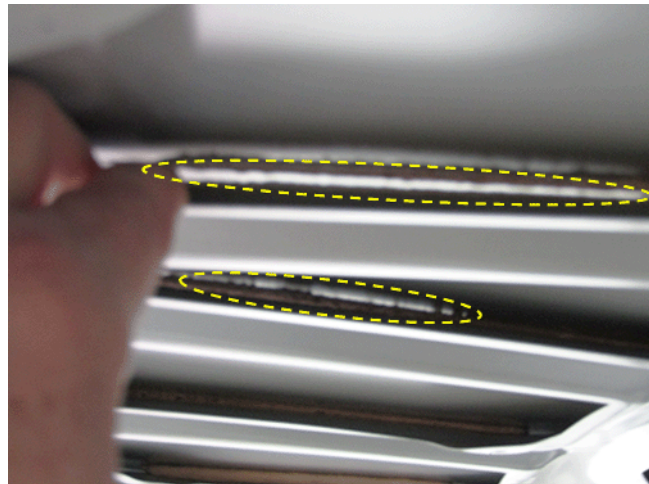
Note: As shown in the graphic examples above, the panels may show evidence of separation and/or a gap or void in the original adhesive material.

The cause of the condition may be that the inner and outer hood panels may not be sufficiently bonded together at all points. At highway speeds or over rough surfaces, the outer sheet metal may show signs of a flutter at some locations.

To prevent the metal from fluttering, apply panel vibration control material between the inner and outer hood panels, following the Service Procedure below.

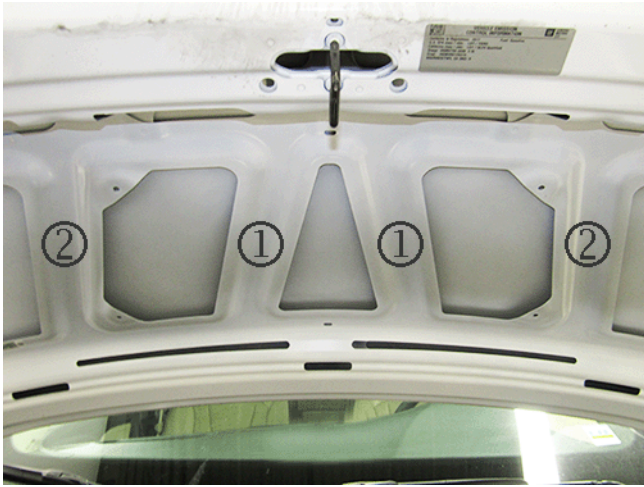
Note: The condition is most commonly found at the two center-most inner panels (1), however in some cases the next outboard inner panels (2) may also be affected.

4. The graphic above shows the areas most likely to require bonding. Examine the underhood panel for signs of original factory shrinkage or insufficient application, similar to the pictures listed in the Cause section.

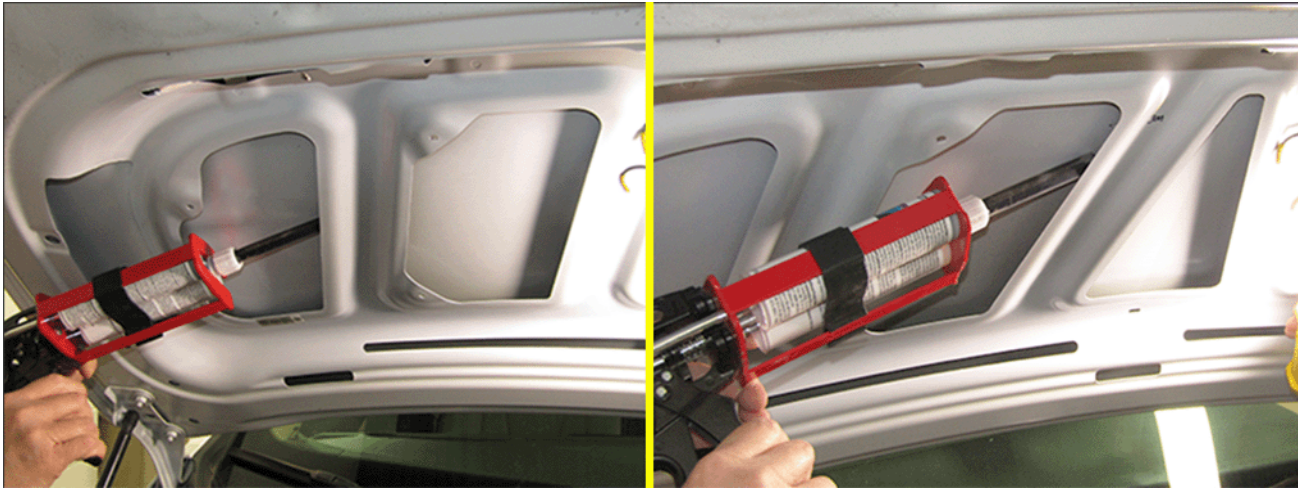
Note: Application to the right side panels is shown in the graphic above.

5. Using a non-expanding two-part panel control vibration material, such as SEM 39977*, 3M™ 04274*, or equivalent, fill the voids between the inner and outer hood panels. Keep the tip of the applicator right up against the panel in order to allow the material to flow in between the panels. Follow the manufacturers instructions for proper application.
