Service Bulletin

Subject: Surge, Hesitation, Chuggle, Misfire Feeling with a Light Tip In

Brand:	Model:	Model Year:		VIN:		Engine:	Transmission:
		from	to	from	to		
Chevrolet	Silverado, Suburban, Tahoe	2017	2017			Equipped with 5.3L Engine (RPO L83)	Equipped with 6 Speed Transmission (RPO MYC)
GMC	Sierra Models, Yukon Models

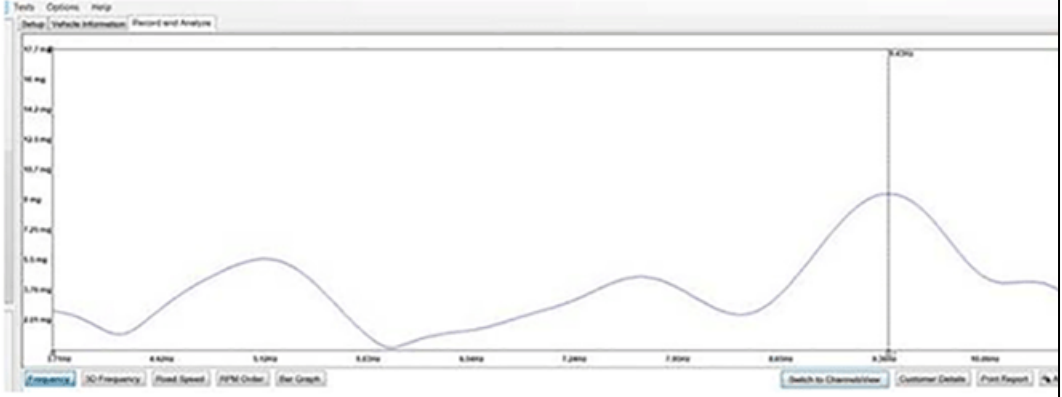
Involved Region or Country	North America and N.A. Export Regions
Condition	Some customers may comment on a hesitation, chuggle, fishbite or roughness that can be felt in gear ranges 3rd–6th gear V8 mode, TCC locked, low RPMs (1200–1300), when tipping into throttle to load engine.
Cause	This condition may be due to modification in the torque converter clutch (TCC) slip targets.
Correction	<p>Test drive and verify the customer concern of chuggle, fishbite or roughness with no diagnostic codes.</p>

<p>Note: This can be confirmed with Picoscope as 10+/-2 Hz frequency. An updated software calibration has been released to address this condition.</p>

Reprogram the transmission control module with the latest calibrations available on TIS2WEB. Refer to *Control Solenoid Valve and Transmission Control Module Assembly: Programming and Setup*.
