Service Bulletin

Subject: Tips for Customers Having Difficulty Launching Android Auto or Apple Carplay

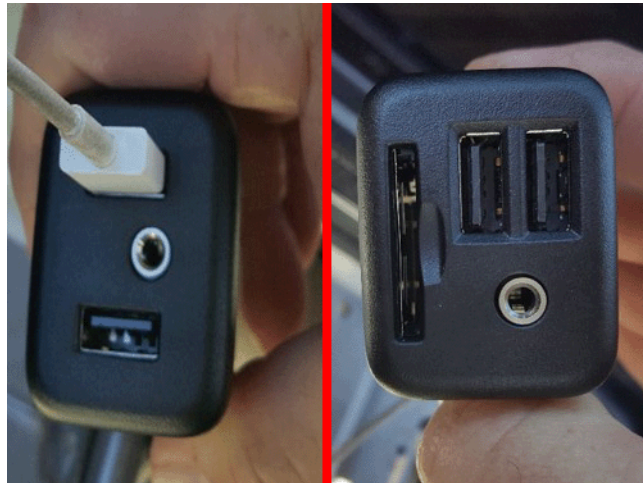
Note: Left Receptacle 2017 Silverado with Radio RPO IOB (Correct), Right Receptacle 2017 Silverado with Radio RPO IOB (Incorrect).

- Ask the dealership to verify that the correct USB receptacle/hub was installed if this started happening right after they replaced the USB receptacle/hub for another complaint like the example above that shows a 2017 Silverado with radio RPO IOB that recently had the incorrect USB receptacle/hub (receptacle shown on the right) installed during service for a non related concern.

Note: To ensure the correct receptacle is installed, cross-reference the part number on the receptacle with the Electronic Parts Catalog all while using the VIN filter feature within the EPC.
