# Service Bulletin

**Subject:** Information on Diesel Exhaust Fuel (DEF) Leaking Past Filler Cap

Brand:	Model:	Model Year:		VIN:		Engine:	Transmission:
		from	to	from	to		
Chevrolet	Colorado	2016	2017			LWN	
GMC	Canyon

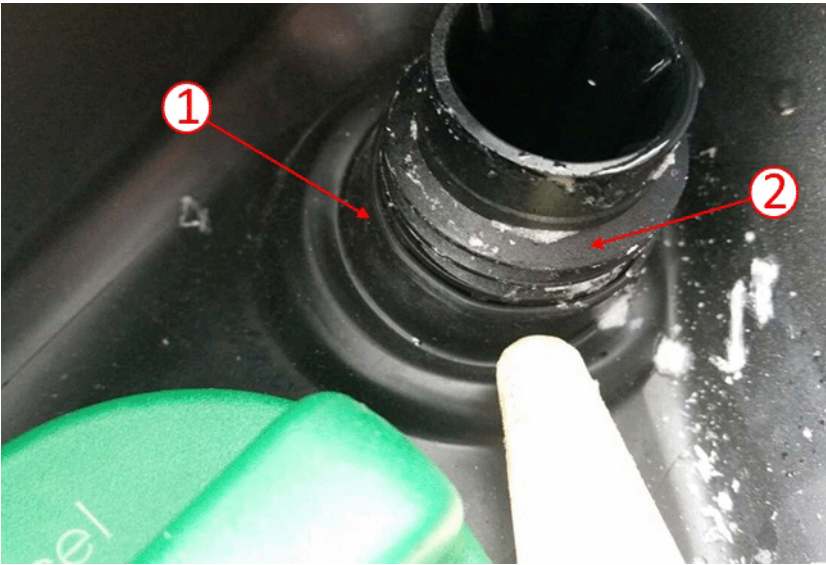
<p>This condition may be caused by the grommet (1) in the fuel housing expanded around the DEF filler pipe cap threads (2).</p>
