Service Bulletin

Subject: Guidelines on Diagnosing and Repairing Front Door Wind Noise

Brand:	Model:	Model Year:		VIN:		Engine:	Transmission:
		from	to	from	to		
Buick	LaCrosse	2017	2017			All	All

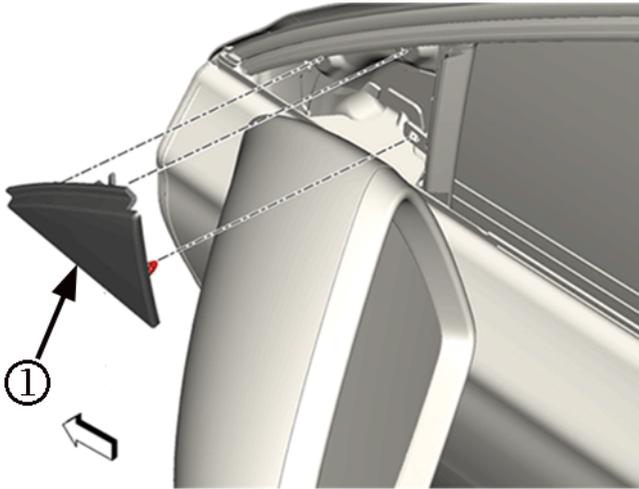
Note: It is NOT necessary to remove the upper and belt door reveal molding for removal/installation of the applique.

1. Remove the front side door window frame front applique (1) on the affected side. Refer to *Front Side Door Window Frame Front Applique Replacement*, in SI.

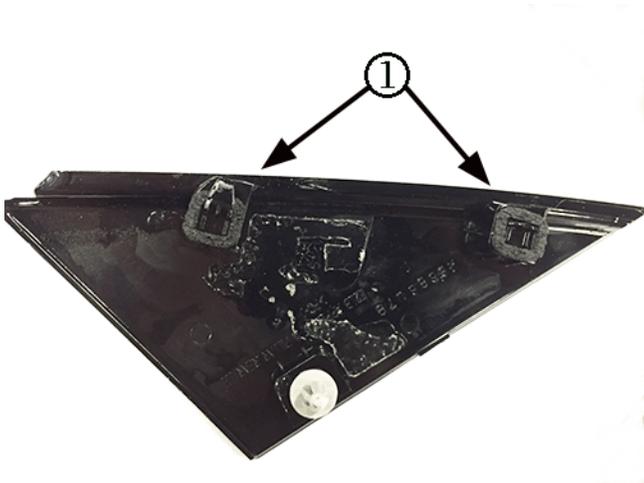
2. Inspect the standing boss foam gaskets (1) on the applique to ensure they are present, properly installed and not damaged.

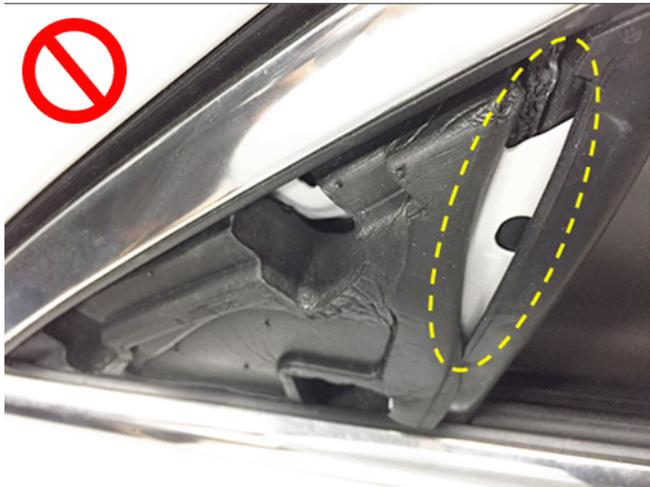
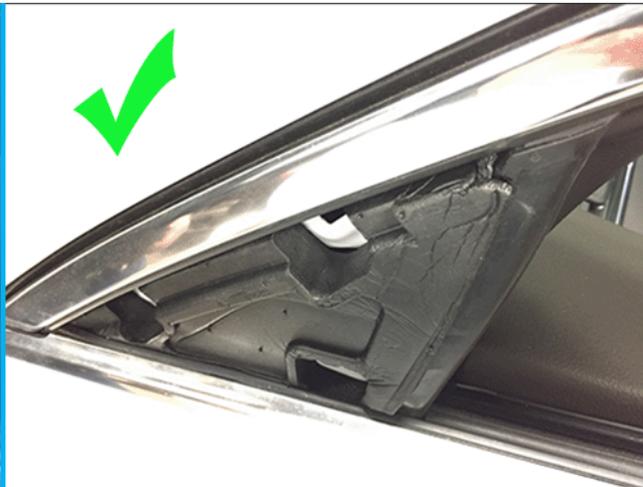
3. Inspect the foam insulator, installed on the door frame under the applique. Ensure it is not damaged, curled under, or rolled over, especially in upper corner.

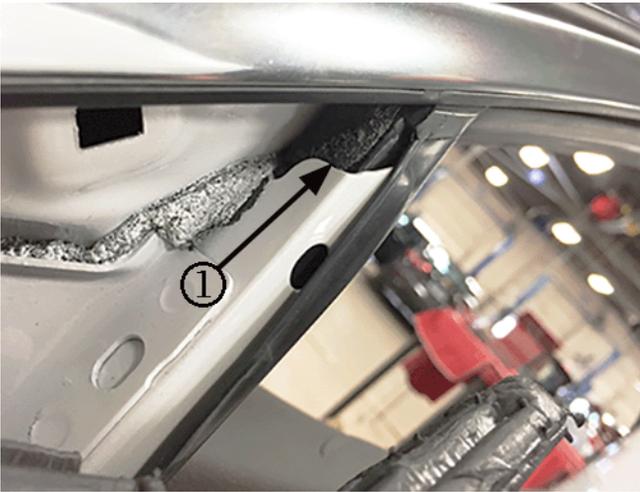
Tip: Also inspect the foam (1) on the glass run seal, underneath the upper corner of the foam insulator. Ensure it is positioned correctly and not damaged.

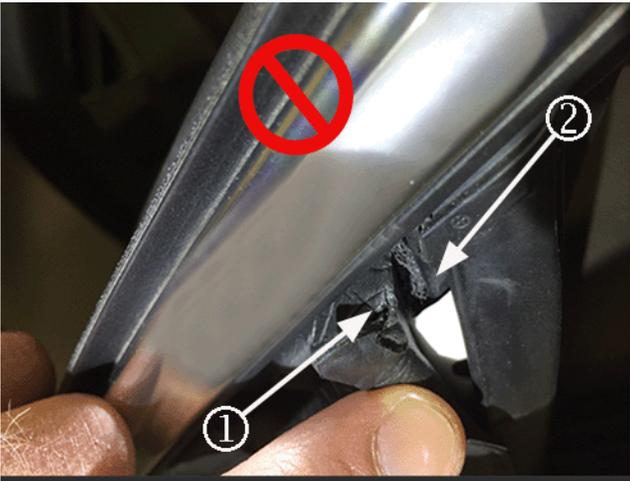
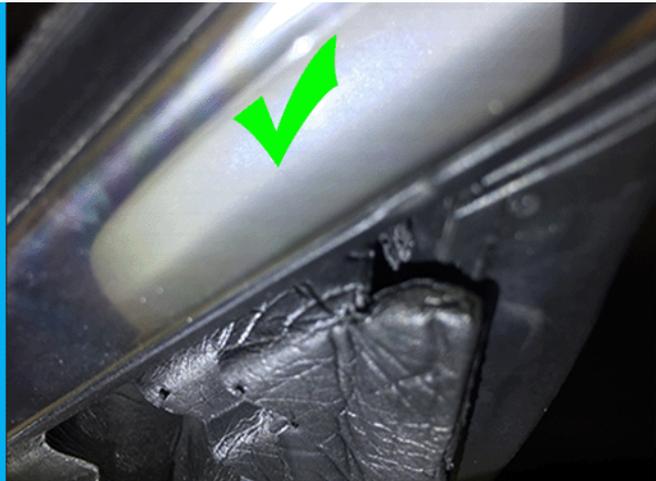
4. Inspect the foam in the outboard upper corner of the window weatherstrip (2). Ensure it is positioned correctly in relation to the insulator (1), and is not damaged.

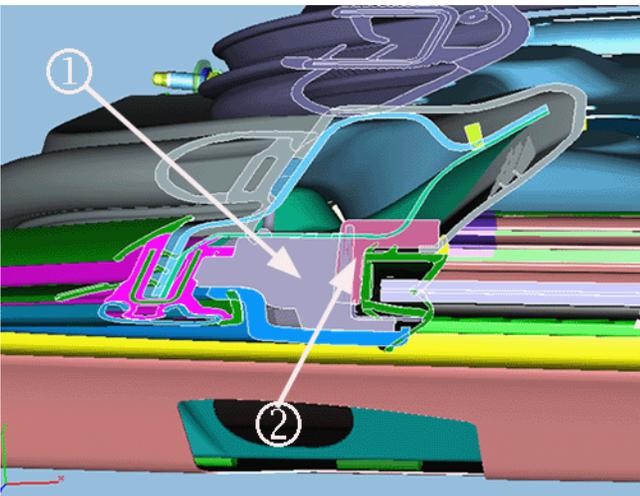
Tip: The cross-section above (cutting through the front applique and door frame) shows the proper interface between the insulator foam (1), and the foam (2) on the upper corner of the weatherstrip.

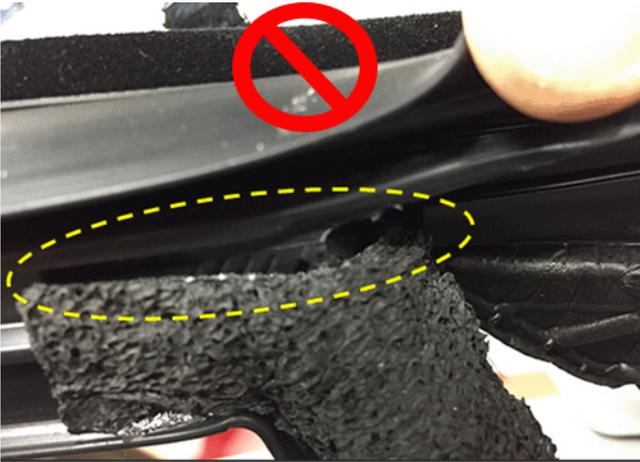
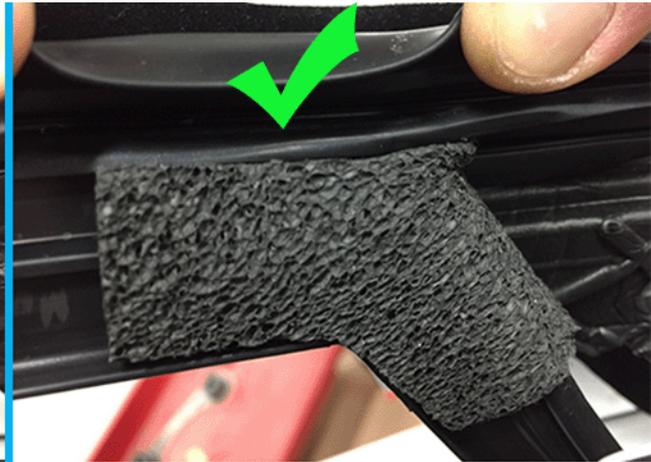
6. Inspect the inboard front upper corner of the window weatherstrip. Ensure that the angled foam pad is positioned all the way up against the weatherstrip and is not damaged.

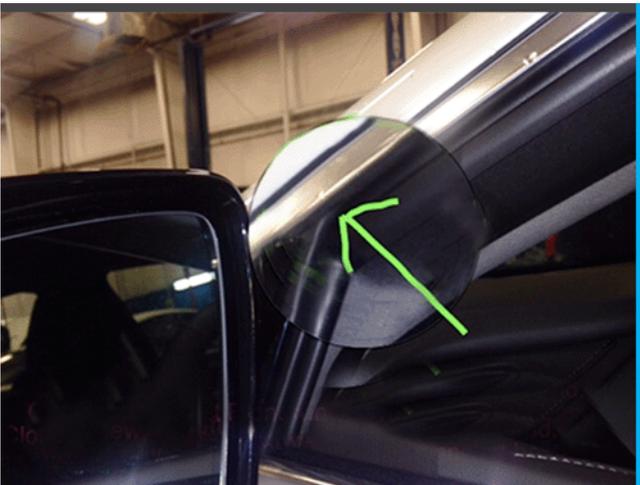
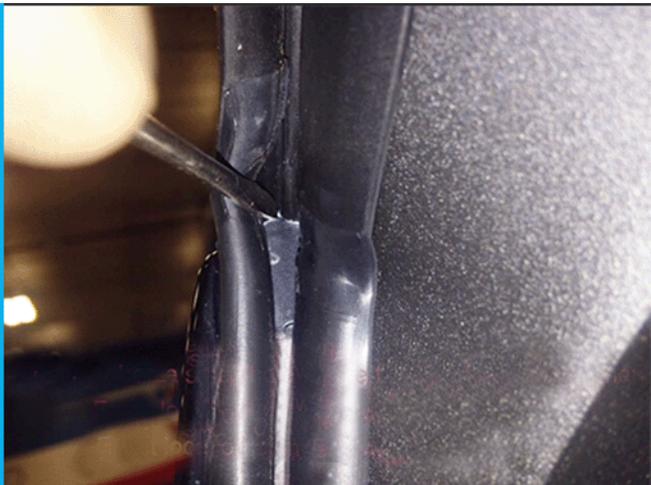
7. Also inspect the inner corner bend of the weatherstrip. The weatherstrip is designed to have a small hole at the bend, however ensure the hole is not damaged/enlarged.

Note: If mis-positioning/damage of the angled foam pad and/or damage to the inner corner of the weatherstrip is evident, it would be necessary to replace the front side door window weatherstrip.

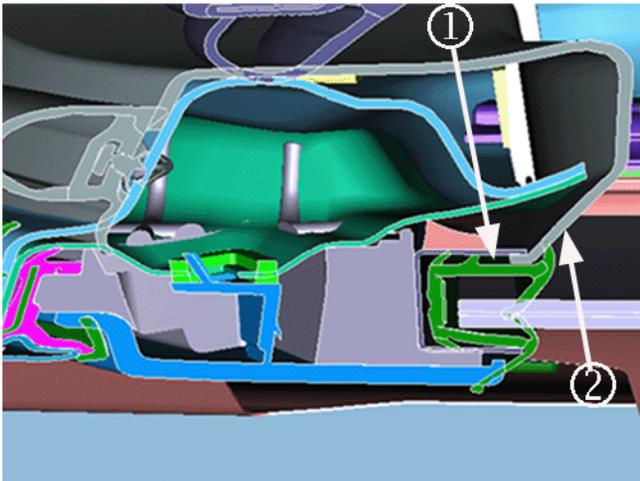
Tip: The cross-section above shows the garnish molding (2) fully seated in and the metal flange (1) of the glass run channel.
