Service Bulletin

Subject: Information on Vibration Analysis and Diagnostic

Models: 2014 Chevrolet Silverado 1500
2015-2017 Chevrolet Silverado
2014 GMC Sierra 1500
2015-2017 GMC Sierra

This PI has been revised to add the 2017 Model Year and update the applicable information below including adding the Replace Steering Bushings section. Please discard PI1354D.

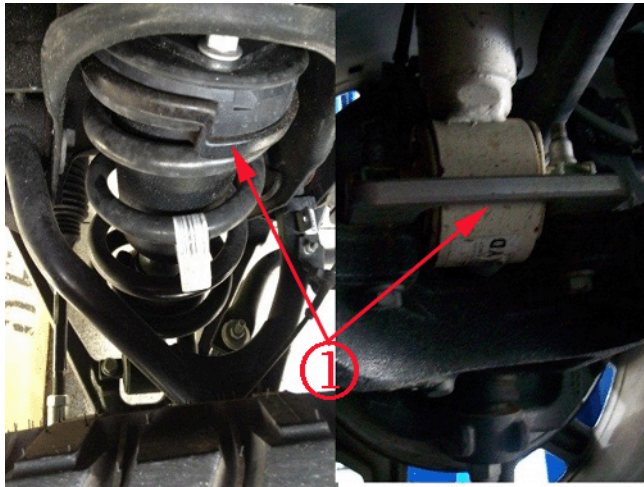
1. Inspect the truck for any aftermarket equipment installations. For example: non factory tires, wheels and/or lift kits or leveling kits – shims (1) installed as shown above. Aftermarket equipment does include running boards, bug deflectors, and window shades, etc. Remove any aftermarket that might cause vibration transmission paths.
2. Mark each tire valve stems location on the tire. This will be utilized to check for tire slippage on the rim.

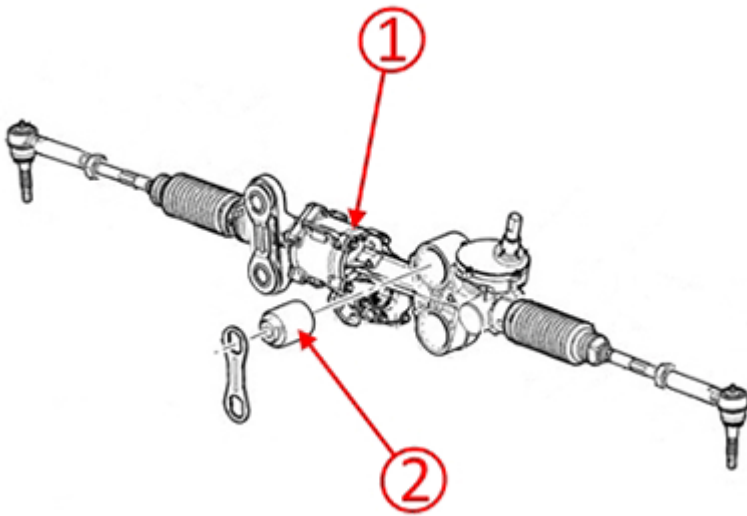
A revised steering bushing (2) has been released to address customer vibration concerns. After various testing and measurement of the T1 vibration, a vibration path from the tie rods =>steering rack=>steering bushings=>frame=>Body Mount=>Cabin Floor=>Seat has been identified. To help isolate the steering rack (1), a revised hydraulic bushing has been released and tuned to the T1 frequency. The new steering bushing dampens minor T1 vibrations. This is the reason that the causal part (normally the Tire/Wheel Assembly) must be corrected first. If the T1 vibration is over 20-25m/g's, the bushings will have little to no effect.

For vehicles with T1 vibrations under 20-25m/g's, replace steering bushing per parts catalogue. Utilize SI procedure "Steering Gear Mount Bushing Replacement" for replacement of the steering bushings.

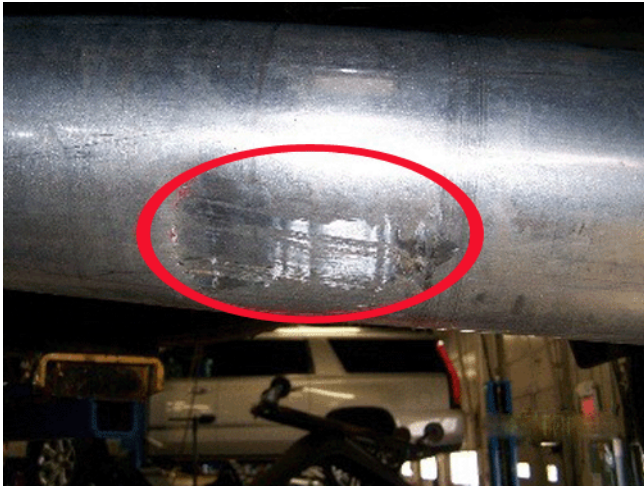
- Inspect the propeller shaft for dents or damage. There have been many cases of dented propeller shafts.
- For 4WD Trucks, remove the rear propeller shaft, seal output shaft and drive the vehicle in 4WD. If the vibration is gone, the rear prop shaft could be the problem.
- For vehicles with a 3:08 with a one-piece steel shaft, this can be replaced with a one-piece aluminum one that is utilized on all 3:42 and 3:73 ratios (K15543 and K15753 Models only).
- PIP5140: Low Speed Vibration 30-35 mph (48-56 km/h).
- Inspect the transmission output shaft bushing for irregular wear.
