Service Bulletin

PRELIMINARY INFORMATION

Subject: Stop/Start System Malfunction or DTC P1064, P1065, P1066, P1068, P1069, P1070, P1074, P1077, P1078, P1079, P107A, P107B, P107C, P107D, P107E, P107F, P108A, P108B, P108C, P108D, P108E or P108F Set

Models: 2016 Cadillac ATS, CTS
Equipped with Stop/Start System (RPO KL9)

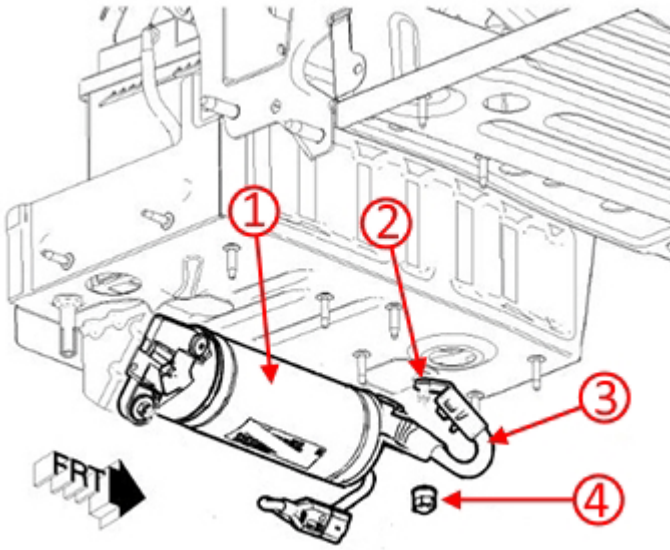
Note: The ground nut can be accessed from under the vehicle and behind the left side rear wheelhouse liner.

9. Check the G402 ground nut at the Start/Stop Capacitor (1) for proper torque.
 - If the torque is within specifications, continue with procedure.
10. Remove the ground nut (4).
11. Inspect and remove any paint on the ground stud (2).
12. Torque the nut to specifications. Refer to Fastener Specifications in SI.
13. Lower the vehicle.
14. Connect the negative battery cable.
