**Subject:** Engineering Information – Oil Leak Between Upper and Lower Oil Pan

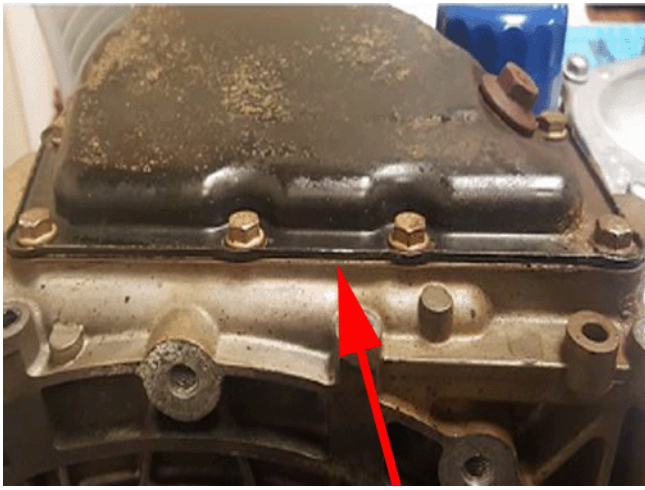
If technician notices an oil leak in between the lower and upper oil pan (red arrow) anywhere around the perimeter, do not attempt to reseal. Contact the engineer listed below prior to completing any repairs.
