Bulletin No.: PIC6275
Published date: 03/27/2017

PIC6275 Intermittent P018B, P0AC4, U18A2, P16E0, Stall, or Reduced Power Message, Cause by a loss of power to the fuel pump drive control module

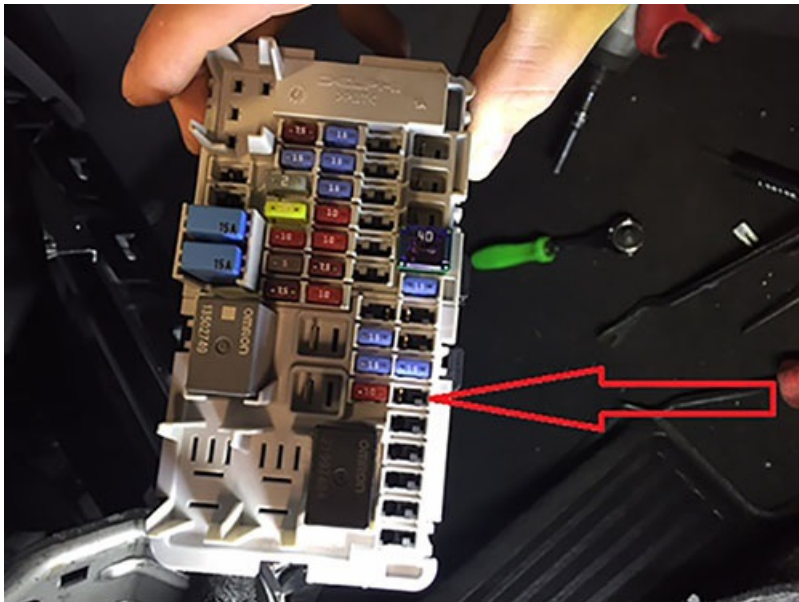
If you have a concern related to the K111 Fuel pump drive control module. Check the X51A Instrument panel fuse panel for a lose terminal to fuse F9DA.

This is could be causing an interment power issue on ckt 1540, Please drag test Terminal 51 at the fuse block using the right test lead.

If a lose terminal is found, Replace it with the right terminated lead listed in SI (Service Information).
