SERVICE BULLETIN

APPLICABILITY: 2005-09MY Legacy and Outback Models **NUMBER:** 12-197-16R
SUBJECT: Melting / Sticky Dashboards / Instrument Panel (IP) **DATE:** 02/25/16
REVISED: 12/27/17

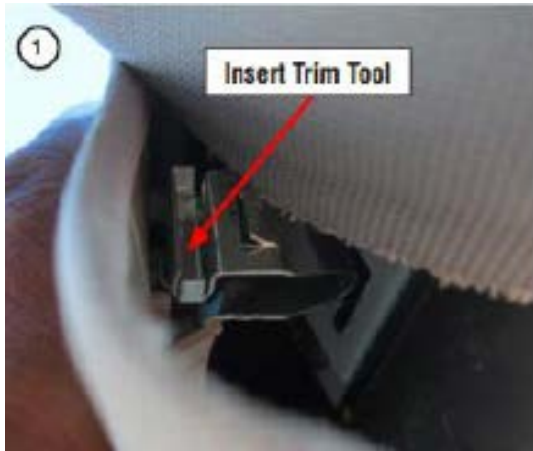
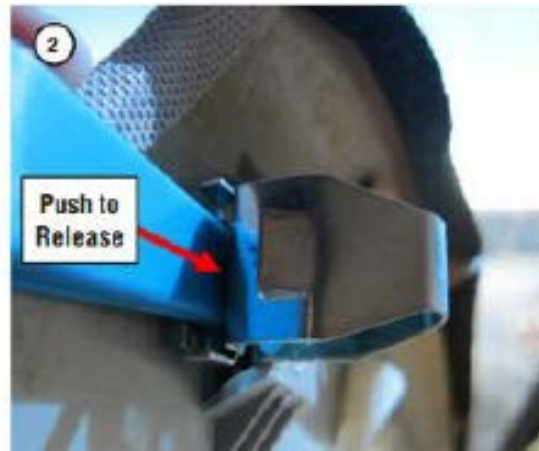
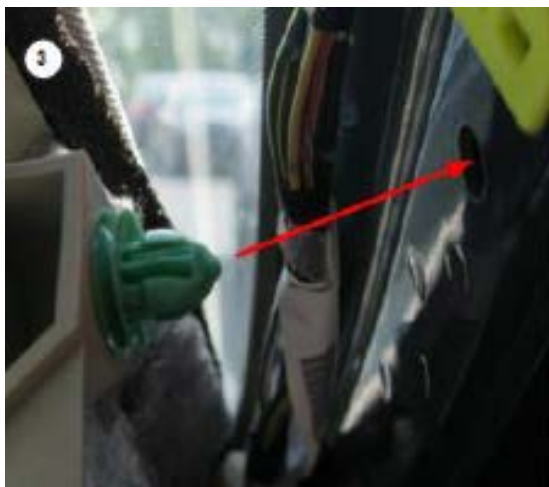
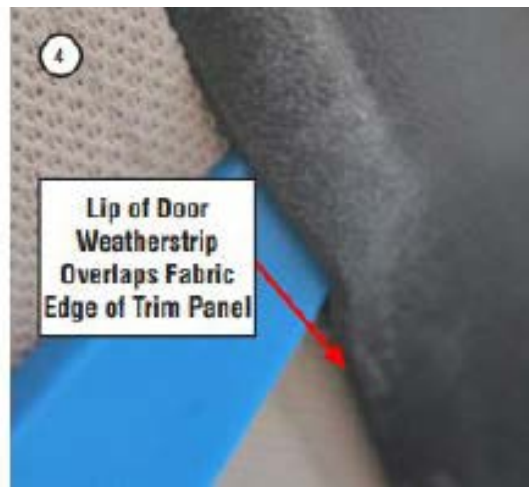
- When removing the “A” pillar trim, be **VERY CAREFUL** not to damage the upper metal retaining clip (see photos below). The clip is located just below where the trim panel meets the head liner. If the metal retaining clip becomes damaged or separated from the trim panel, the “A” pillar trim panel **MUST** be replaced as the clip is not available separately. **DO NOT** attempt to straighten or reuse the clip if it becomes damaged. Use a plastic trim tool to push down (1 & 2) and release the upper portion of the metal clip from the body. Be careful to not pull the trim panel open any further than necessary to gain access for releasing the clip. There is also a plastic retaining clip (3) in the lower portion of the trim panel which will release easily once the upper retaining clip is loose. At reassembly and using a plastic trim tool, make sure the inner lip of the door weather strip overlaps the outer fabric edge of the trim panel (4) to help secure it.

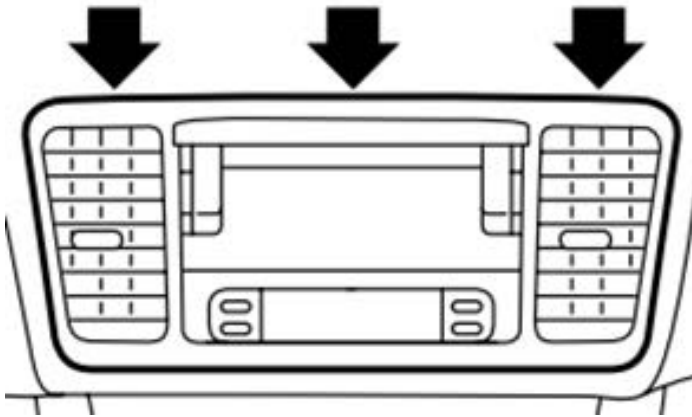
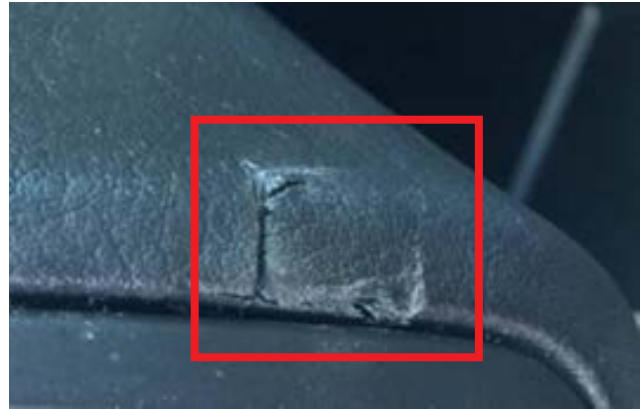
- When removing the center vent / storage box assembly, **CAREFULLY** release the 3 retaining claws shown in the illustration below using a plastic trim tool. Always support the trim tool against the IP (example: a second trim tool placed horizontally between the first tool and the IP) to distribute the prying force and avoid damage as shown in the example photo. Remember to disconnect (and reconnect) the trip computer's wiring harness connector.

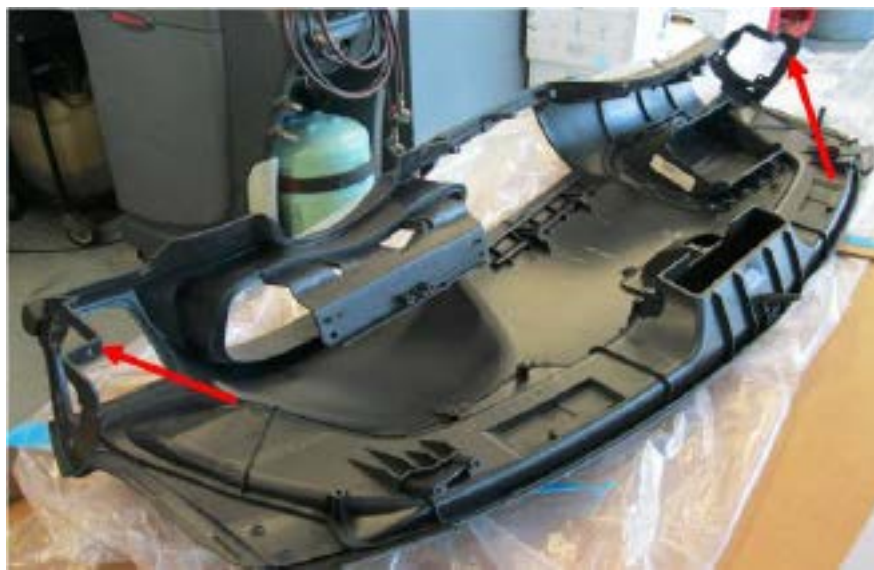
- Always use caution when removing the new IP from the plastic shipping bag. Pay close attention to the mounting brackets on each end of the new IP as indicated in the photo below. They can easily be broken if the heavy plastic shipping bag is removed too hastily.

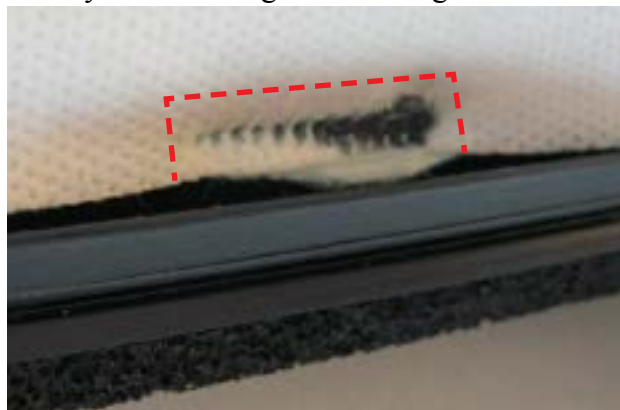
- As shown in the photo above, the replacement IP does not include the white insulation material. Although the ductwork does the bulk of holding the insulation in proper position, there are a few places where it is heat-fused as shown in the photo below to the original part. **CAREFULLY** cut around the fuse point with a small utility knife or scissor to release it then pull the insulation away from the original IP taking care to not tear it.

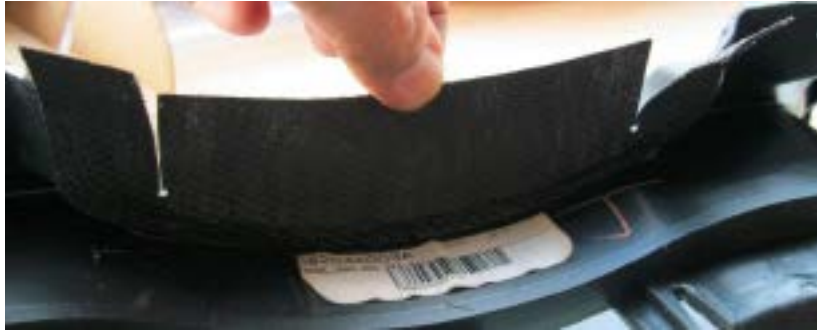
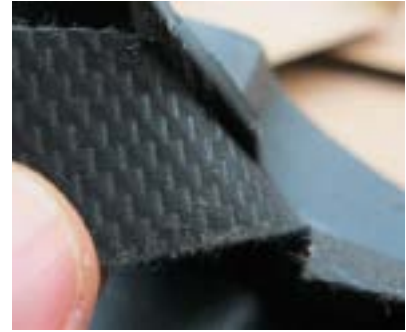
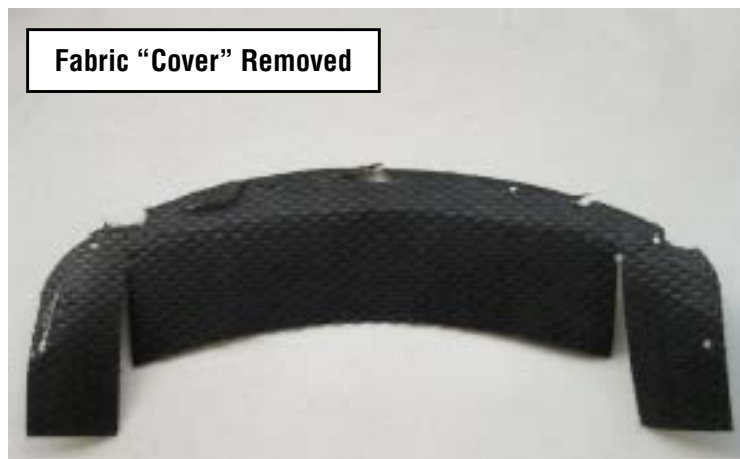
- There is a small piece of fabric-type material which acts as a “cover” for the gap between the top of the steering column and the underside of the combination meter area of the IP. This small trim piece must also be **VERY CAREFULLY** removed and transferred to the new IP. A small hobbyist knife or equivalent carefully worked in between the material and IP to break the glue bond works well. **PATIENCE** is the key!

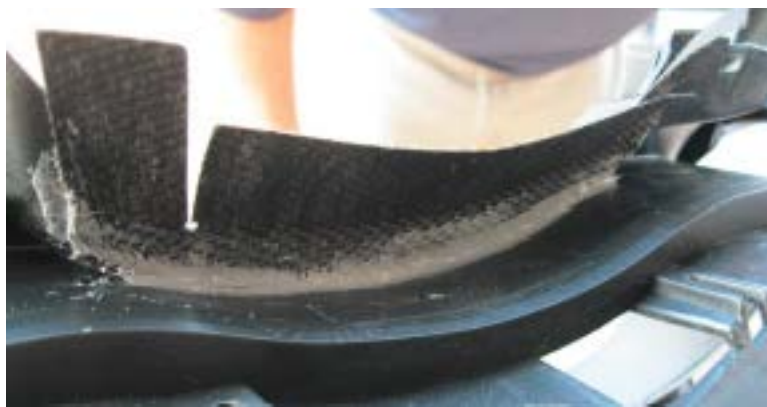
- Once the cover is removed, a **VERY** small amount of black or clear silicone sealer / adhesive works well to “tack” it into position on the new IP. Once in place, a small “fillet” of black or clear silicone can be applied from the back side as shown below to fully secure it in place. (Gray was used for photo.)

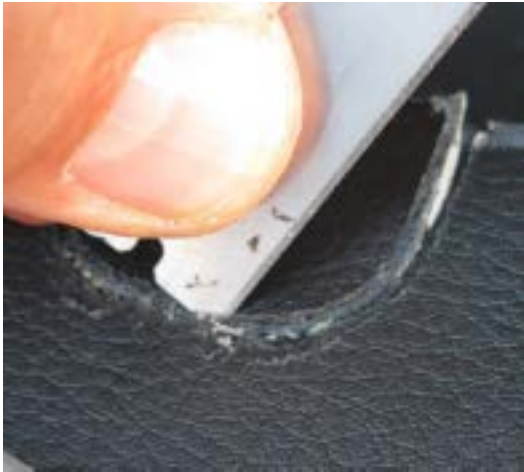
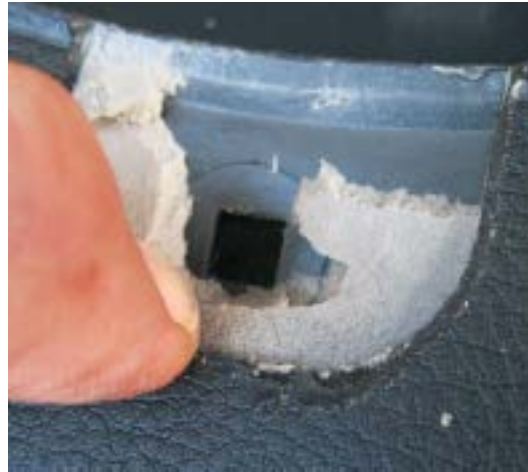
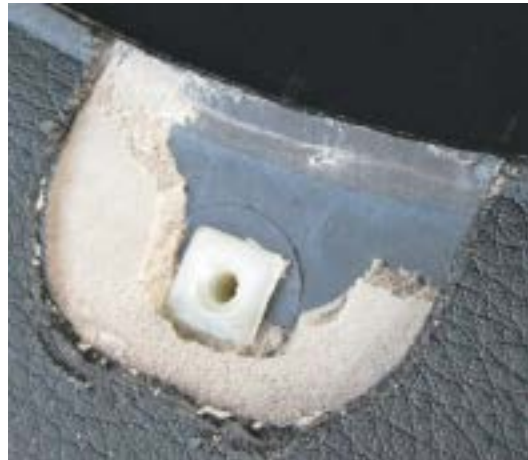
- **VERY CAREFULLY** using the molded-in groove as a guide, trim the IP as shown to gain access to the square hole for the combination meter top retaining screw clip. After cutting, peel away the trim surface then the foam underneath it to access the square hole for the clip.

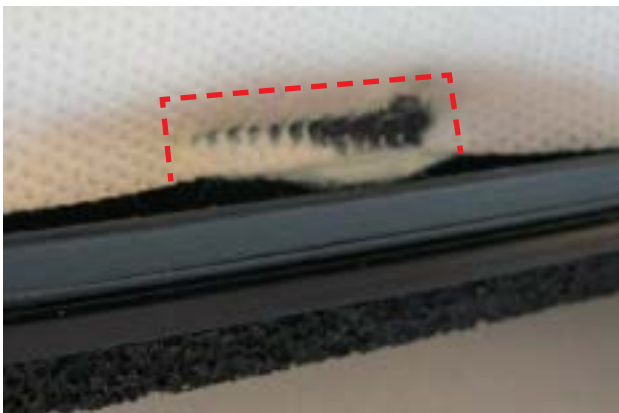
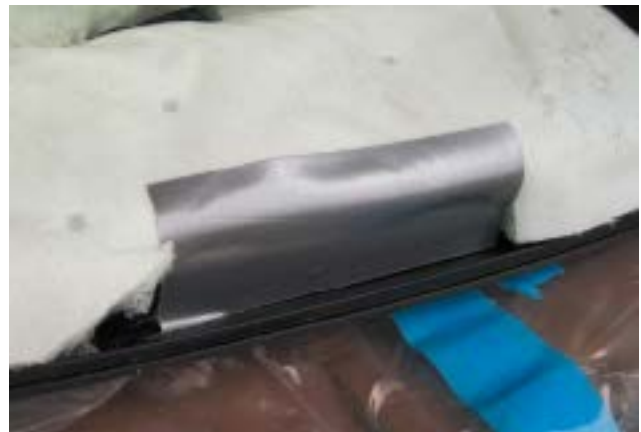
- Along the front edge, (closest to the windshield), there are 2 places where the insulation is heat-fused to the IP. Using a sharp scissor, cut the fuse points off the insulation and use tape to secure it to the new IP as shown below.

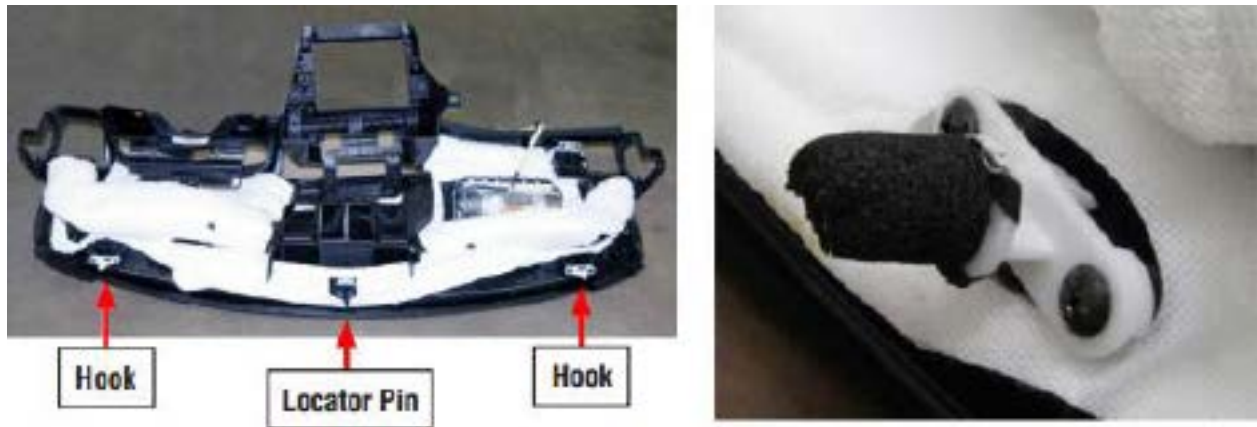
- Before installing the new IP, to eliminate a possible source of a rattling sound, wrap both hooks and the center locator pin with non-woven material, p.n. SOA963W110 (or an equivalent self-adhesive foam) as shown in the photos below.
