SERVICE BULLETIN

APPLICABILITY: 2015-2017MY Legacy and Outback
 2015-2017MY Impreza and XV Crosstrek
 2015-2016MY Forester
 2016-2017MY WRX
 2015-2016MY BRZ

NUMBER: 15-199-16R
DATE: 05/05/16
REVISED: 12/20/17

SUBJECT: Reprogramming File Availability to Address Operational Concerns with 6.2” Clarion Display Audio Unit

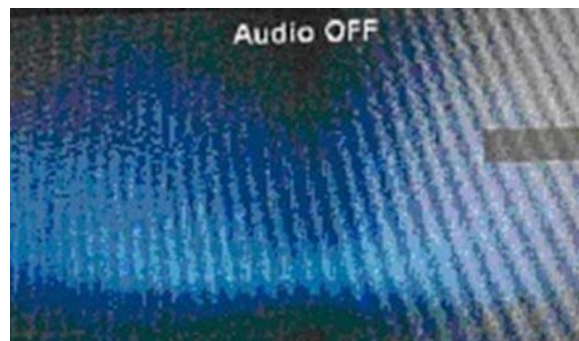
- Audio unit freezes and restarts when inserting and removing USB memory (flash drive).
- CD player stops playing audio and / or elapsed time display freezes.
- While talking on a paired phone and using the Bluetooth feature, audio unit restarts when shifting into Reverse.
- Audio unit restarts when receiving a Bluetooth phone call. The display goes black and may be accompanied by a “popping” sound.
- White stripes or streaks appear on the display as shown below.

This bulletin announces reprogramming file availability and the software installation procedure to address a group of operational concerns received from the field and listed below involving the Clarion Display Audio unit with 6.2” display. The procedure will involve downloading the applicable software update files from Subarunet then loading them onto a flash drive for audio unit installation.

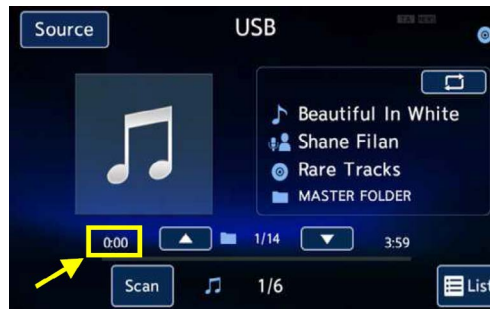
- When listening to music from a USB drive, the elapsed play time counter stays at 0:00.

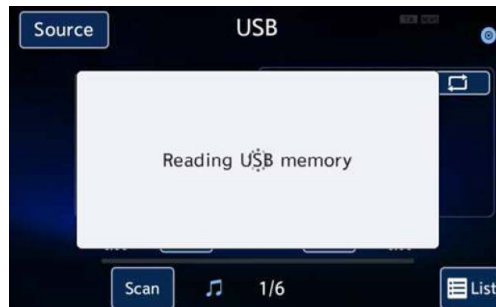
- When listening to music from a USB drive, the music plays normally but the screen display shows “Reading USB Memory”.

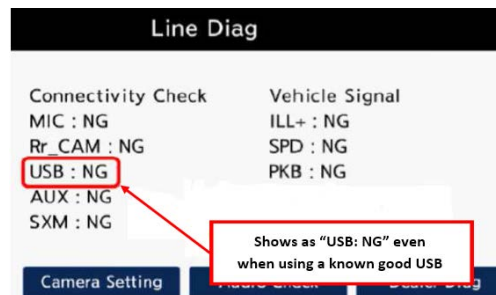
- In diagnostic mode, “USB: NG” is displayed even though a known good USB drive is plugged in.

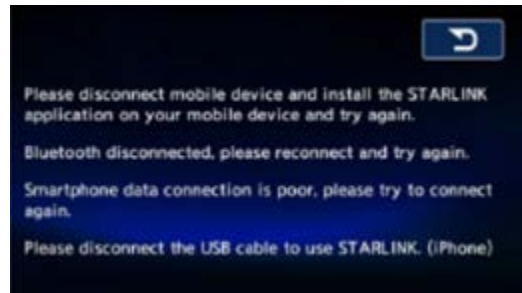
- When using the Magellan Navigation smartphone application (Release date 11/1/2016) for approximately 6 hours, the Bluetooth disconnects and the route guidance screen freezes. An error message screen displays asking the user to disconnect their mobile device, install the STARLINK application on their mobile device and try again along with three other connection-related messages.

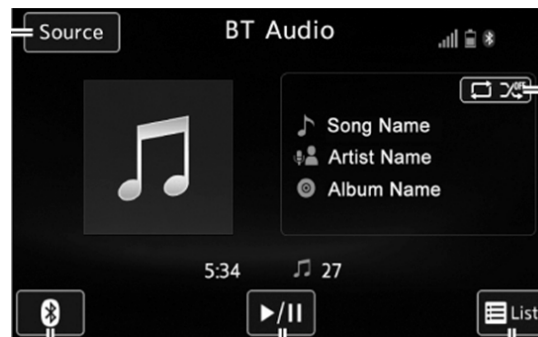
- All the function keys such as the steering switch, hard keys on the head unit and touch panel (display) become inoperative after playing music for 3-4 hours using a Bluetooth-connected device and no input from any of the keys on that connected device. When this occurs, music continues to play normally but the display screen freezes.

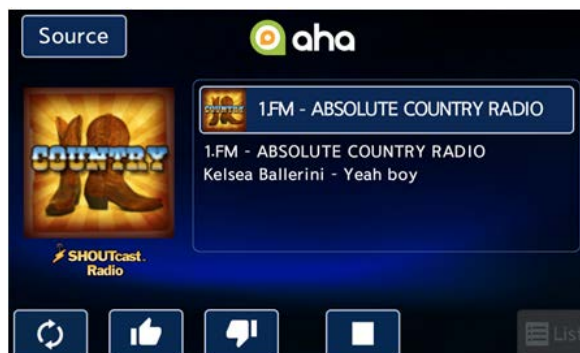
- ✓ When making a hands-free call using the voice command function, the ring-back tone is not heard from the speakers.
- ✓ When making a hands-free call using the voice command function, the user enters the number using the phone's buttons but, a dial tone is not heard from the speakers.
- ✓ When receiving a call using the hands-free and voice command functions, the ringtone is not heard from the speakers.
- When using the ahaRadio feature, song title and artist information does not update after the previous song ends.
