**NUMBER:** 08-041-17

**GROUP:** 08 - Electrical

**DATE:** June 1, 2017

RAN / RAP Radio Enhancement

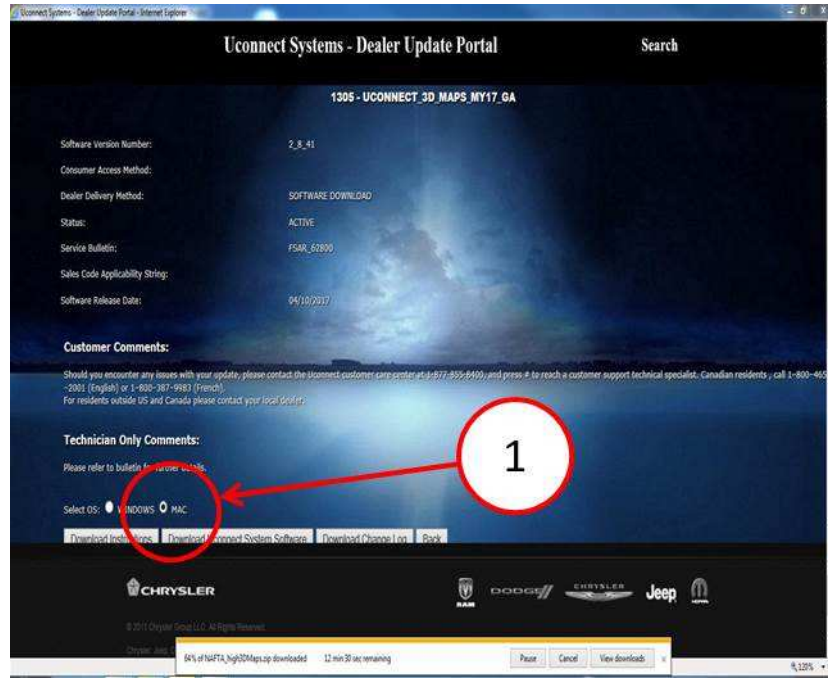
Fig. 2  
Uconnect Update Portal

1 - Select the "MAC" Radial Button

4. To download the software files to a USB flash drive, follow the on-screen instructions and perform the following:
- Acquire a blank USB flash drive with at least 16 GB of space.
  - The USB flash drive must be formatted as New Technology File System (NTFS) structure.
  - Download the software update file to your local PC's desktop. Make sure to select the "MAC" radial button for all downloads (Fig. 2) .
