NUMBER: 08-042-17 REV. B

Flash: RE2 and RB5 Radio Enhancements

This bulletin involves inspecting and if required, updating the radio software.

2017 (JC) Dodge Journey

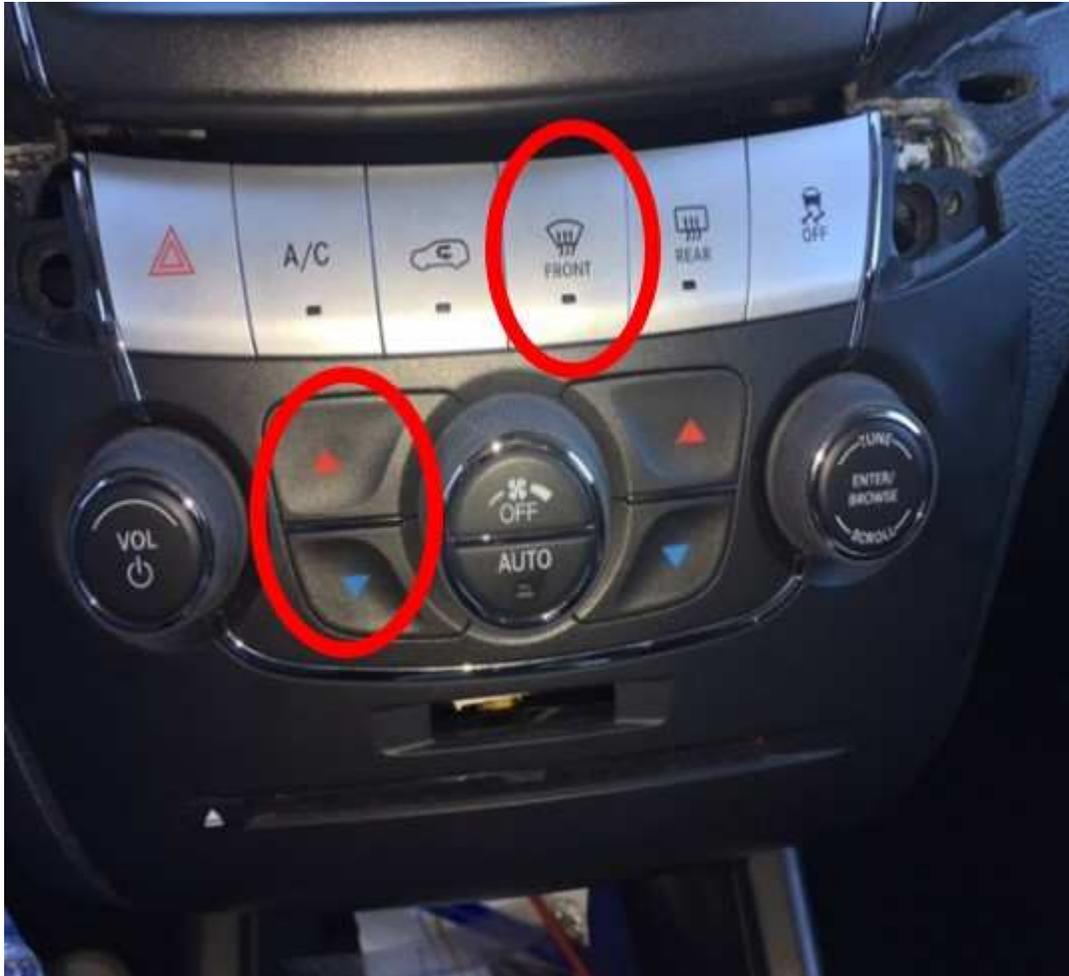
Fig. 1

Removing From Shipping Mode

1. Take radio out of Shipping Mode, Press the driver side temperature up, driver side temperature down and the front defrost buttons together and hold for a period or 5 seconds or longer (Fig. 1) .

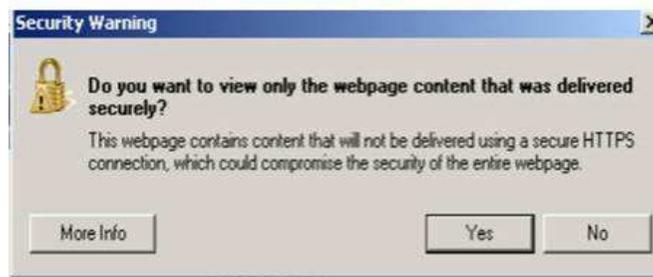
Fig. 2
Pop-up Security Message

5. If a security message appears “Do you want to view only the webpage content that was delivered securely?” See (Fig. 2) Press **No** to continue.

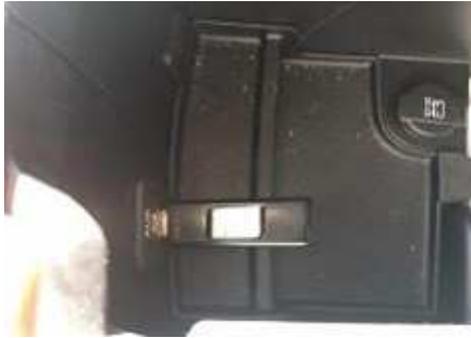
Fig. 3
USB Port

7. Install the correct USB flash drive containing the radio control head update into the USB port (Fig. 3) .

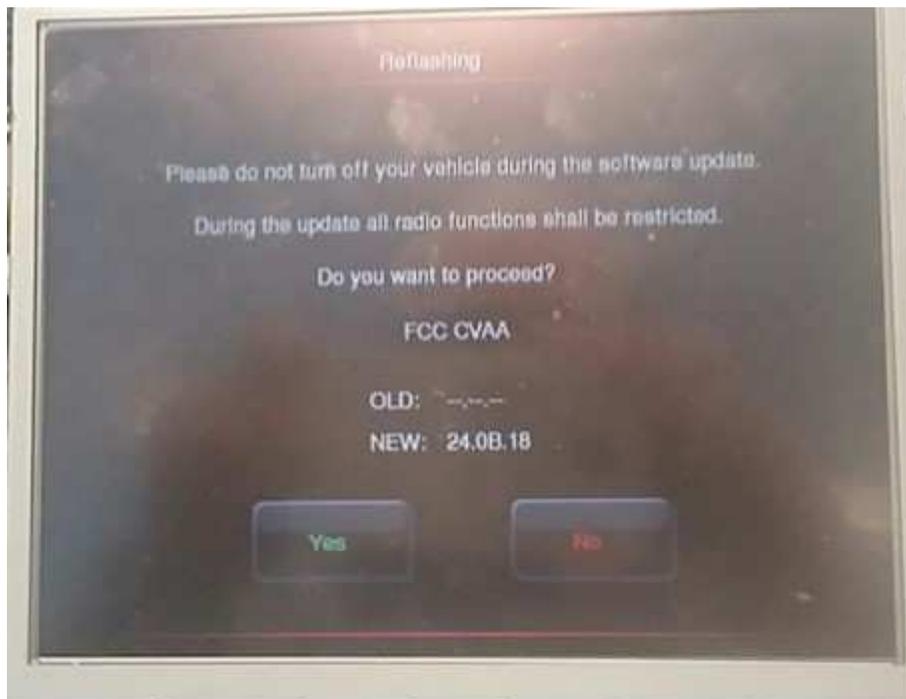
Fig. 4
Update Screen

9. Is the current/old radio control head software level at or higher than the new software level?
 - a. Yes >>> The radio control head is already up to date. Remove the USB flash drive and proceed to [Step 13](#) to verify proper operation.
 - b. No >>> Radio software needs to be updated (Fig. 4) , proceed to [Step 10](#).

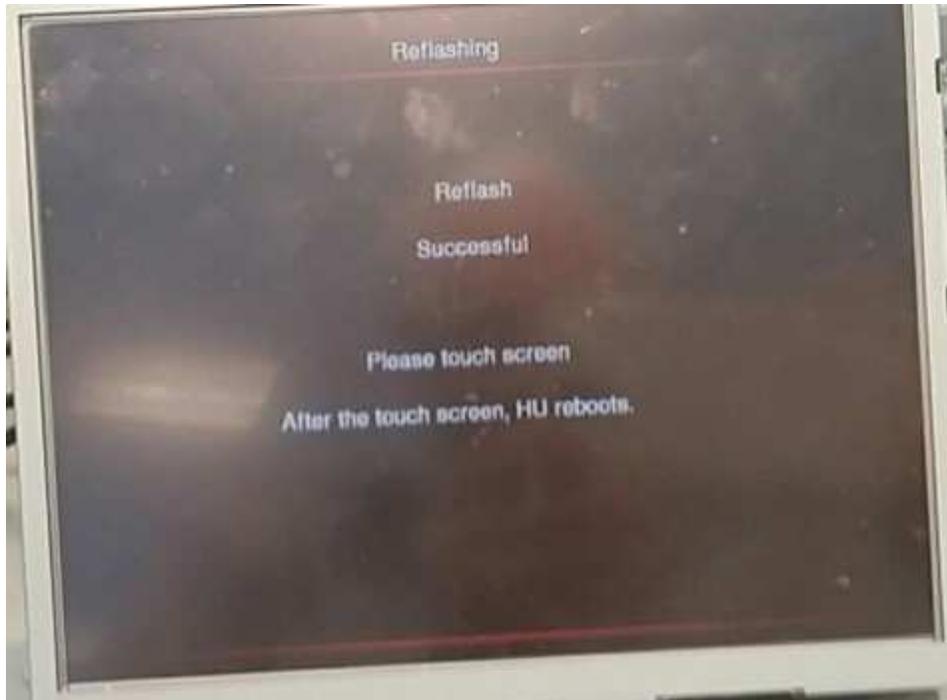
**Fig. 5
Reflash Successful**

11. When the update is completed, the screen will read “Reflash Successful”. Touch the screen and the radio will reboot (Fig. 5) .

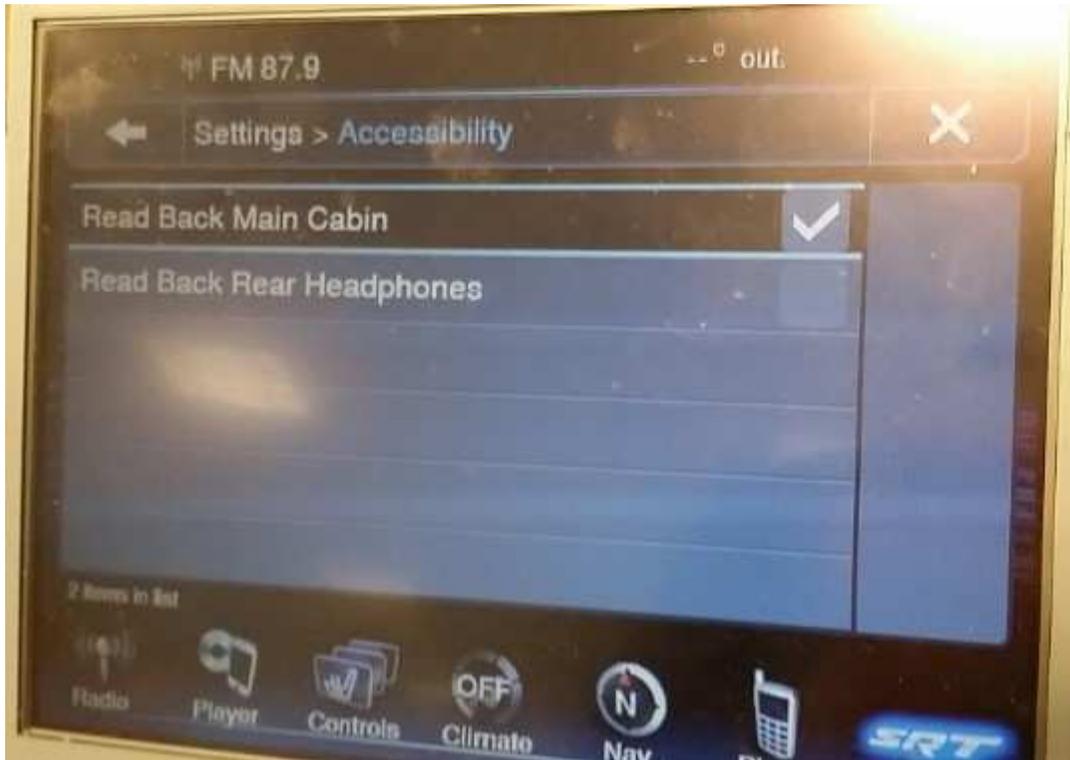
Fig. 6
Testing The Flash

13. To test for a successful flash, enable FCC setting from the Accessibility menu (Setting ->Accessibility ->Read back main Cabin) (Fig. 6) .

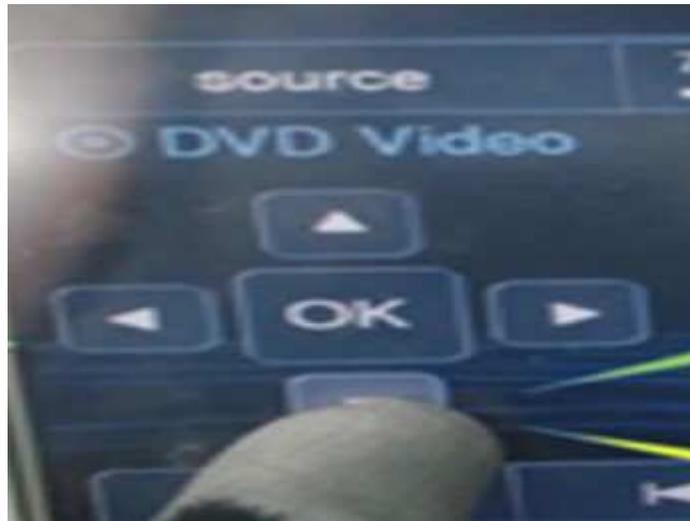
Fig. 7
Functional Test

- 14. Insert a DVD into the radio for testing.
- 15. Touch any function button on the DVD screen, you should hear the button pressed (Fig. 7) .
