NUMBER: 21-024-17

Transmission Oil Pan Leaking

2017	(D2)	RAM 3500 Pickup
2017	(DJ)	RAM 2500 Pickup

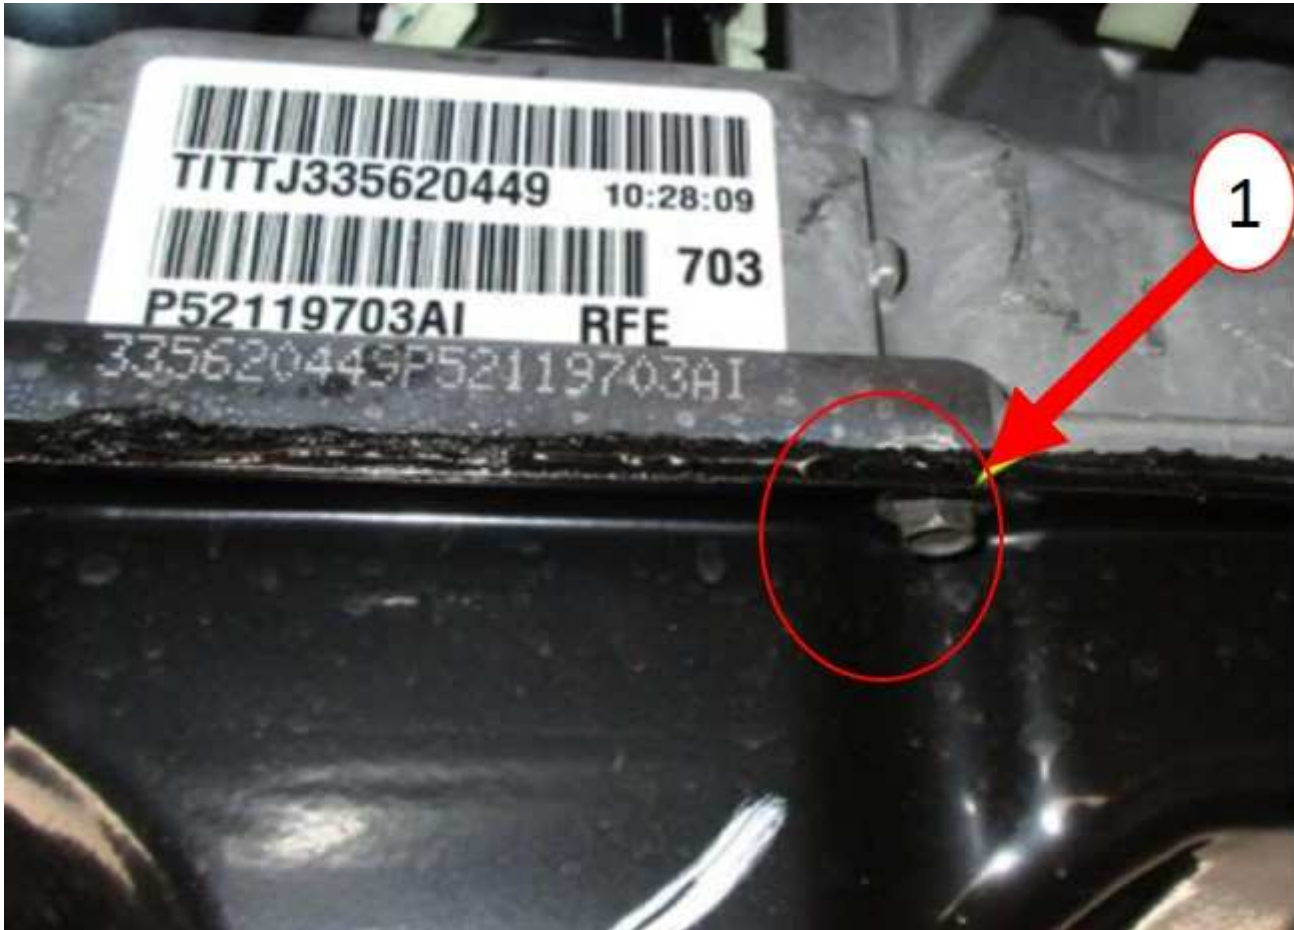
Fig. 1
Transmission Oil Pan

Some customers or technicians may experience a transmission oil leak. Upon further investigation, a technician may find the transmission oil pan is leaking in this suspected area (Fig. 1).

1 - Suspected Leak Area

2. Remove transmission oil pan by removing the bolts holding the pan to transmission.
3. Slowly separate front of pan away from transmission allowing the fluid to drain into drain pan.

4. While holding pan level, lower pan away from transmission.
5. Pour remaining fluid in pan into drain pan and dispose of properly **do not reuse old fluid**.

6. Using a suitable gasket scraper, clean original sealing material from surface of transmission case and the transmission oil pan.
7. Place bead of Mopar® part # 05010884AD RTV sealant onto the transmission oil pan sealing surface.

8. Place pan in position on transmission.
9. Install oil pan. Tighten pan bolts to 12 N·m (105 in. lbs.) torque.
10. Lower the vehicle. Refer to the detailed service procedures available in DealerCONNECT> TechCONNECT under: Service Info>04 - Vehicle Quick Reference/Hoisting/Standard Procedure Standard Procedure - Hoisting.
