**NUMBER:** 08-049-17

Central Vision Processing Module (CVPM) Enhancements for Surround View Camera System

2017 (RU) Chrysler Pacifica

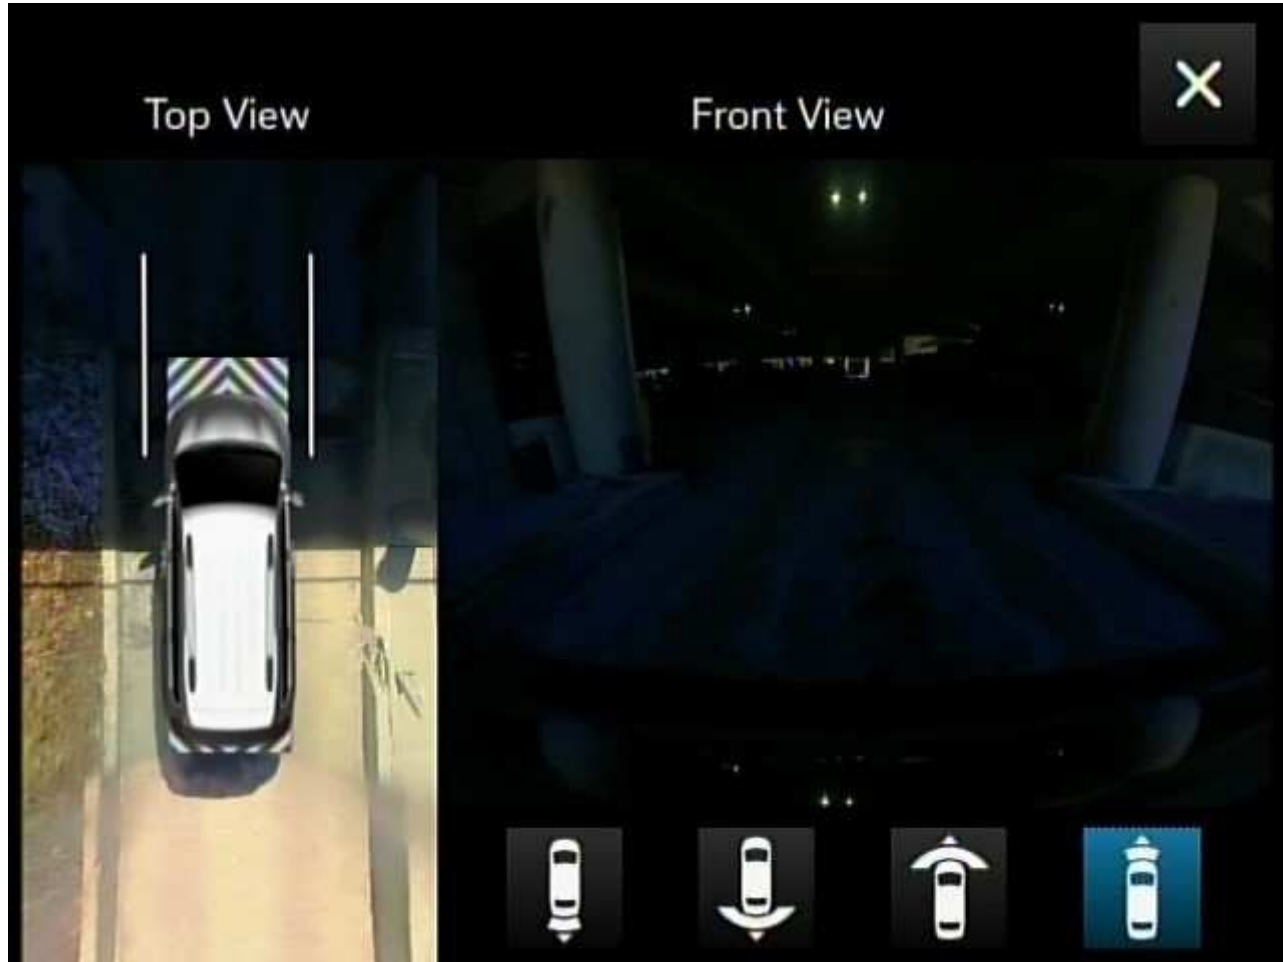
Fig. 1  
360 Surround View Camera

Customers may experience that in variable light conditions (i.e. backing into a garage on a sunny day), image harmonization between the four views can lead to part of the image being blacked out (Fig. 1) .

1. Reprogram the CVPM with the latest available software. Detailed instructions for flashing control modules using the wiTECH Diagnostic Application are available by selecting the application's "HELP" tab.

2. Once programming is completed, cycle the ignition to the run position.
3. Clear all DTCs that may have been set in any module due to reprogramming. The wiTECH application will automatically present all DTCs after the flash and allow them to be cleared.
4. Verify proper operation after codes are cleared.
