**NUMBER:** 25-003-17 REV. A

Flash: Dosing Control Unit (DCU) Diagnostic and System Improvements

This bulletin involves reprogramming the DCU with the latest available software and if necessary replacing the unit.

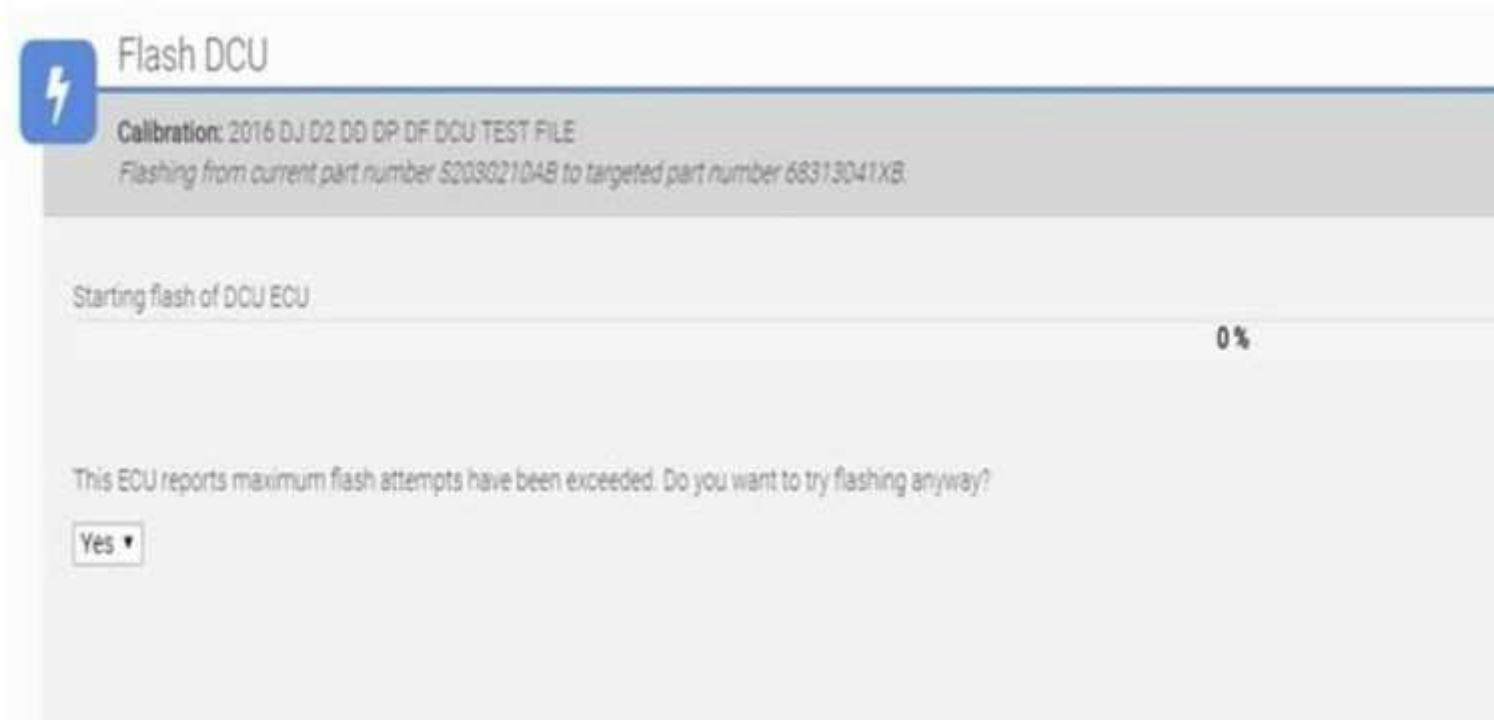
**Fig. 1**  
**Maximum Flash Attempts**

1. Using wiTECH, check for any codes setting in the PCM and record them on the repair order. If necessary, perform a vehicle scan report and save it for your records.
2. **\*\*Using WiTech, attempt to reprogram the DCU with the latest available software. Did you receive the message "This ECU reports maximum flash attempts have been exceeded"?** (Fig. 1)
  - a. YES>>> Proceed to [Step 3](#).
  - b. NO>>> Proceed to [Step 9](#).

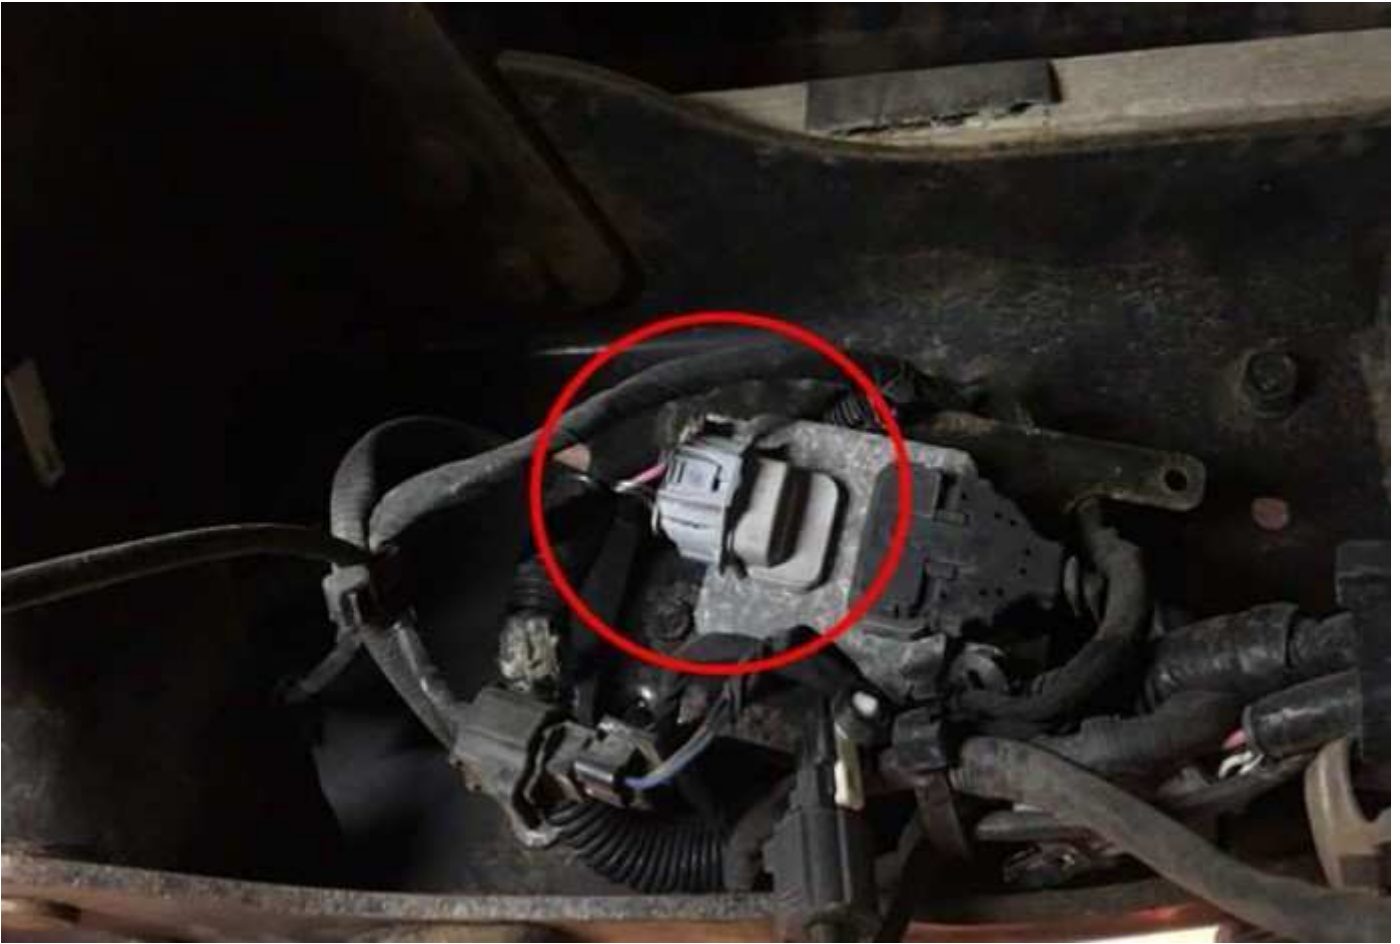
**Fig. 2**  
**NOx Sensor Electrical Connector**

3. Key on the vehicle to the RUN position.
4. Disconnect the NOx sensor 1/2 electrical connector (Fig. 2) (located in the passenger side frame rail channel towards the rear axle).

7. Once the light is green, remove the flash counter tool.
8. Reconnect the NOx 1/2 sensor electrical connector (Fig. 2.) \*\*
9. Reprogram the DCU with the latest software. Detailed instructions for flashing control modules using the wiTECH Diagnostic Application are available by selecting the application's "HELP" tab.

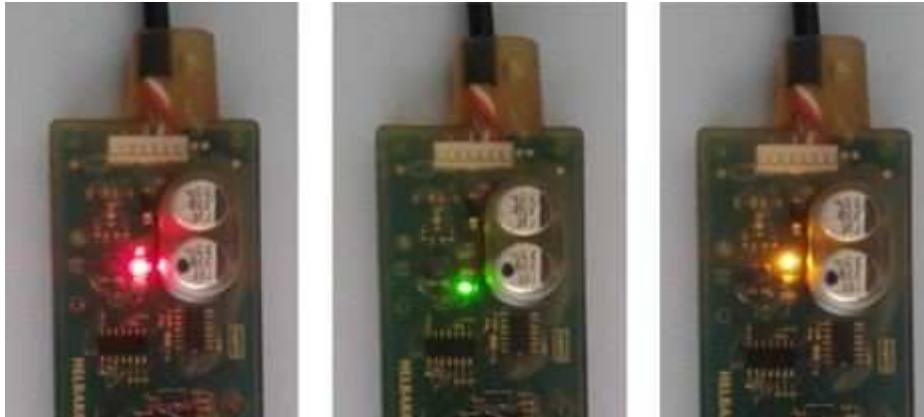
Fig. 4

6. Red indicator means the tool is in progress. Wait for the light to turn green (usually goes from red to green in less than a second)(Fig. 4.)

**NOTE: If the tool lights up yellow, something went wrong in the process. Unplug the device and wait for 5 seconds. After 5 seconds repeat Step 5. After two attempts if the light does not turn green, the DCU must be replaced and reprogrammed. Replace the DCU. Refer to the detailed service procedures available in DealerCONNECT> TechCONNECT under: Service Info>25 - Emissions Control/Diesel Exhaust Fluid Emissions/Unit, Diesel Exhaust Fluid Dosing Control/Removal/Installation.**
