NUMBER: 23-030-17

Hood Seal Torn or Deformed

2015 - 2017

Dodge Challenger

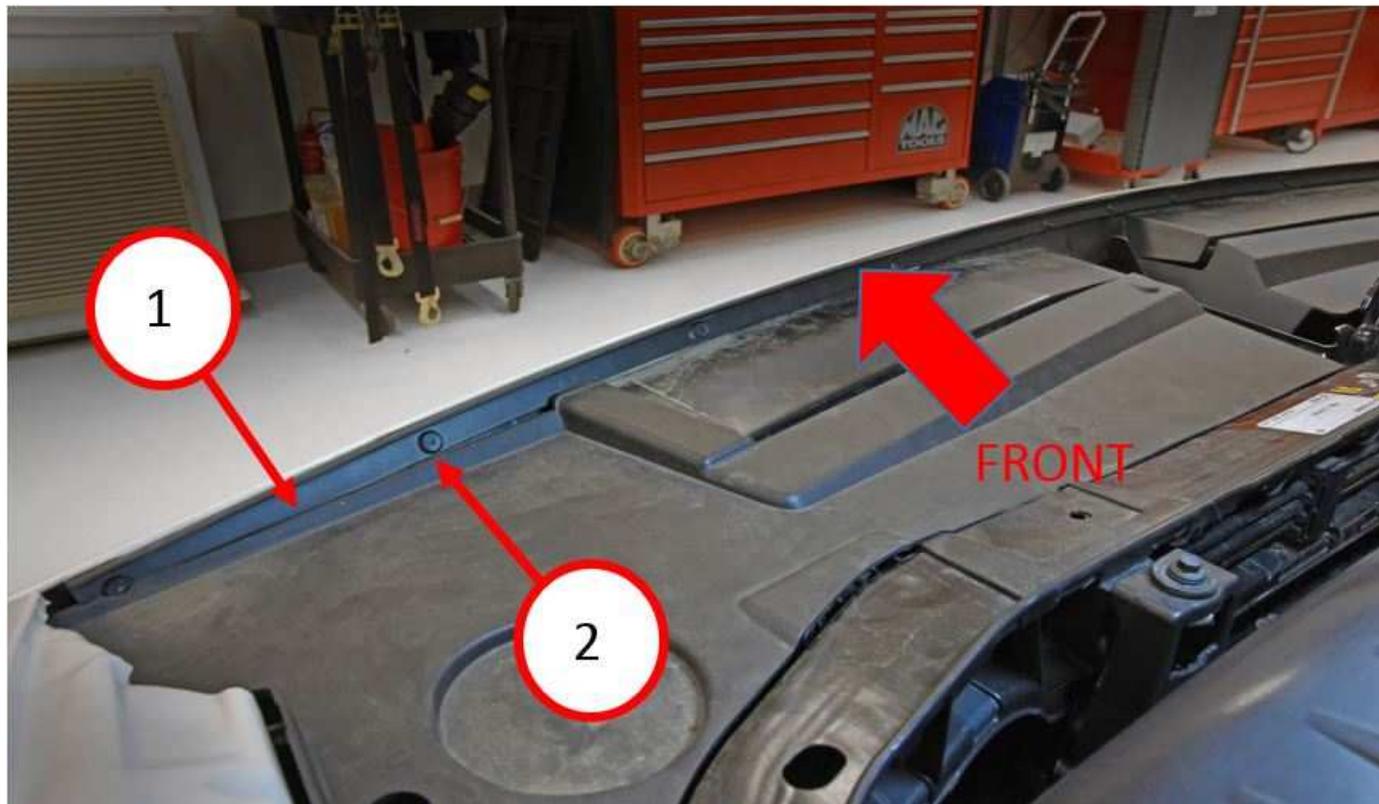
Fig. 2

The customer may experience the hood seal drooping due to cracks and tears on the hood seal.

- 2. Remove all hood seal retainers (plastic rivets) and the hood seal (Fig. 2) . Replace with new hood seal and retainers listed in Parts Required.
