NUMBER: 08-047-17

GROUP: 08 - Electrical

DATE: June 10, 2017

Flash: RA3/RA4 Radio Software Enhancements

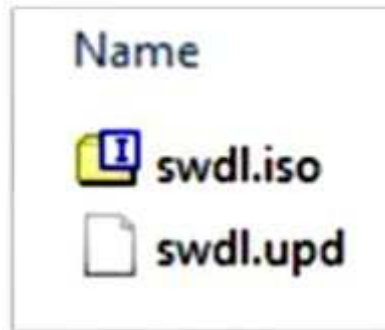
Fig. 1
Two USB Files

NOTE: Two files will be loaded onto the USB flash drive (Fig. 1) .

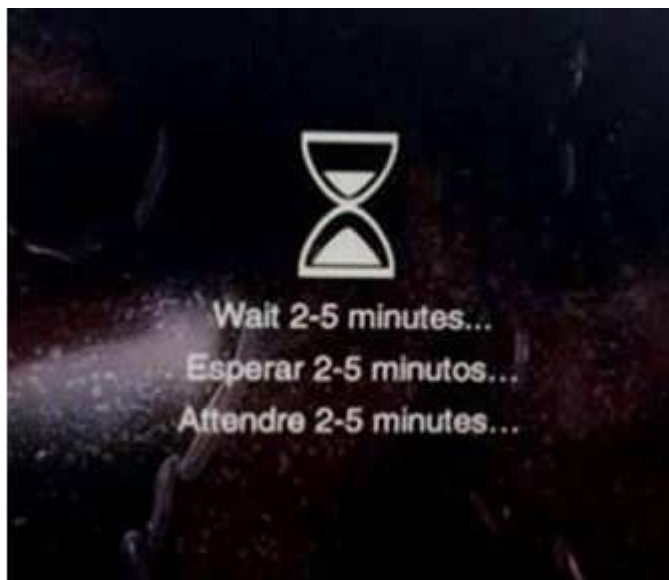
**Fig. 3
Hourglass Screen**

NOTE: **During the update process you will see multiple hourglass and “Please Insert Update USB” screens for extended periods of time (several minutes)(Fig. 3) or (Fig. 4) . DO NOT remove the USB flash drive at this time. Only remove the USB flash drive when the update has completed, when the screen displays the software levels again. The screen will say “Software updated successfully”.**

NOTE: During the update process, the screen on the radio will display an hourglass and blue screen that said “Please Insert Update USB” for approximately two to five minutes at a time ([Fig. 3](#)) and ([Fig. 4](#)).

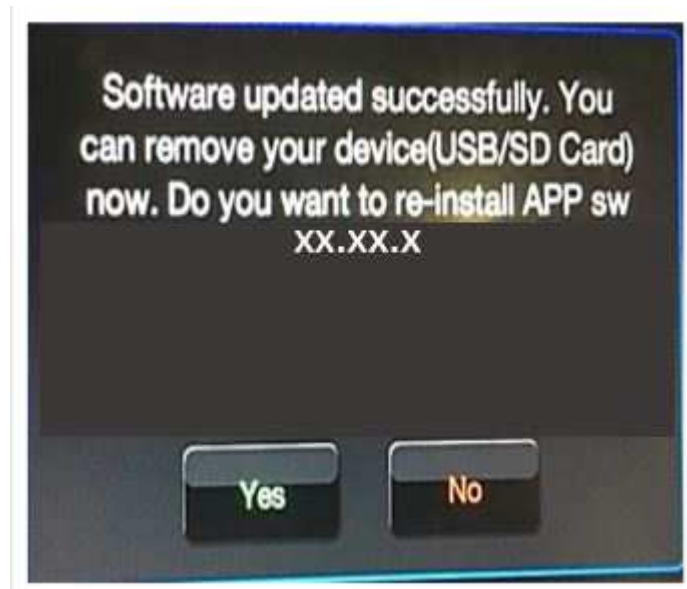
Fig. 5

10. ****After the update is done the screen will display the software levels again and will prompt to remove USB ([Fig. 5](#)).**

****Software Updated Successfully****
