Service Bulletin

Bulletin No.: 17-NA-097

Subject: Side Blind Zone is Not Working Correctly and/or Incorrect Side Mirror Notification

Brand:	Model:	Model Year:		VIN:		Engine:	Transmission:
		from	to	from	to		
Chevrolet	Bolt EV	2017	2017	SOP	June 1, 2017		
Opel / Vauxhall	Ampera-e

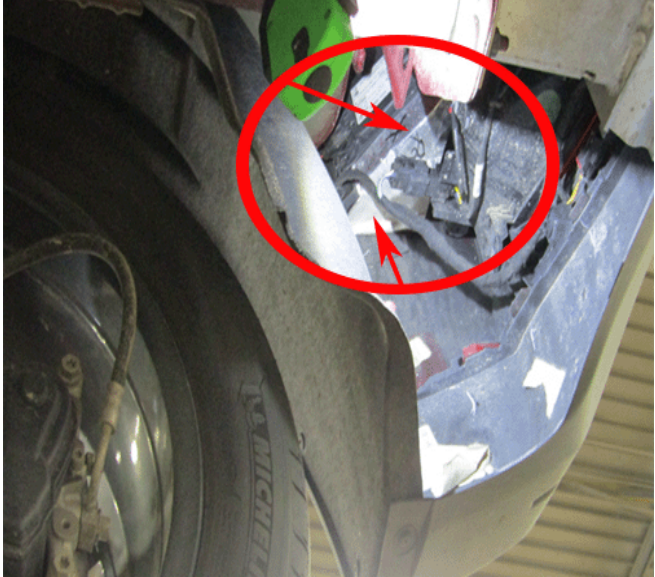
</div> <p style="text-align: right;">4749843</p> <p>Inspect the wiring harness electrical connectors for proper connections and routing.</p>

Involved Region or Country	North America, Europe, South Korea, Middle East
Additional Options (RPOs)	Equipped with Side Active Safety Obstacle Detection Enhanced (RPO UKC)
Condition	<p>Some customers may comment when driving, the side mirror indicates there is a vehicle present when there actually is not.</p> <p>The technician may find one or more of the following conditions:</p> <ul style="list-style-type: none"> • Wiring harness to the sensors may not be properly connected or routed. • Butyl tape not covering the sensor bracket completely. • Butyl tape missing completely.
Cause	<p>If the side blind zone has been found not working properly, inspect one or more of the following areas:</p> <ul style="list-style-type: none"> • Butyl tape application at the sensor brackets. • Sensor harness electrical connection and routing. • Poor grounding at the G401 and/or G404 body ground.
Correction 1	<div style="text-align: right;">
