Service Bulletin

Bulletin No.: 17-NA-151

Subject: Outside Noise Heard from Back of Cab

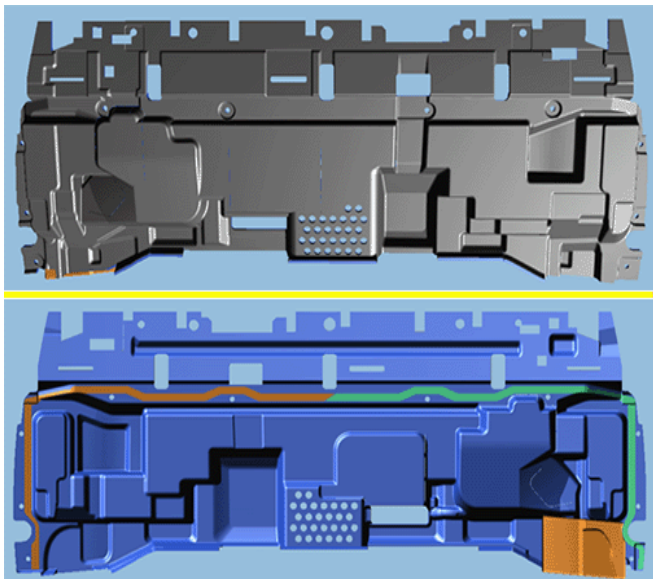
4791130

Inspect the rear cab insulator to verify which insulator the vehicle contains:

- If the vehicle contains the **3D** insulator shown in the front and rear view examples above, **DO NOT** replace the insulator. No further repairs are recommended.
- If the vehicle contains the **2D** insulator shown in the front and rear view examples above, acoustic performance can be gained by replacing the insulator with the **3D** design. Replace the body rear panel insulator. Refer to *Body Rear Panel Insulator Replacement* in SI.
