# Service Bulletin

Bulletin No.: 15-NA-051

**Subject:** Vehicle Stalls While Driving, No Start/Stalling

Brand:	Model:	Model Year:		VIN:		Engine:	Transmission:
		from	to	from	to		
Buick	Lucerne	2008	2011			All	All
Cadillac	DTS	2009	2011

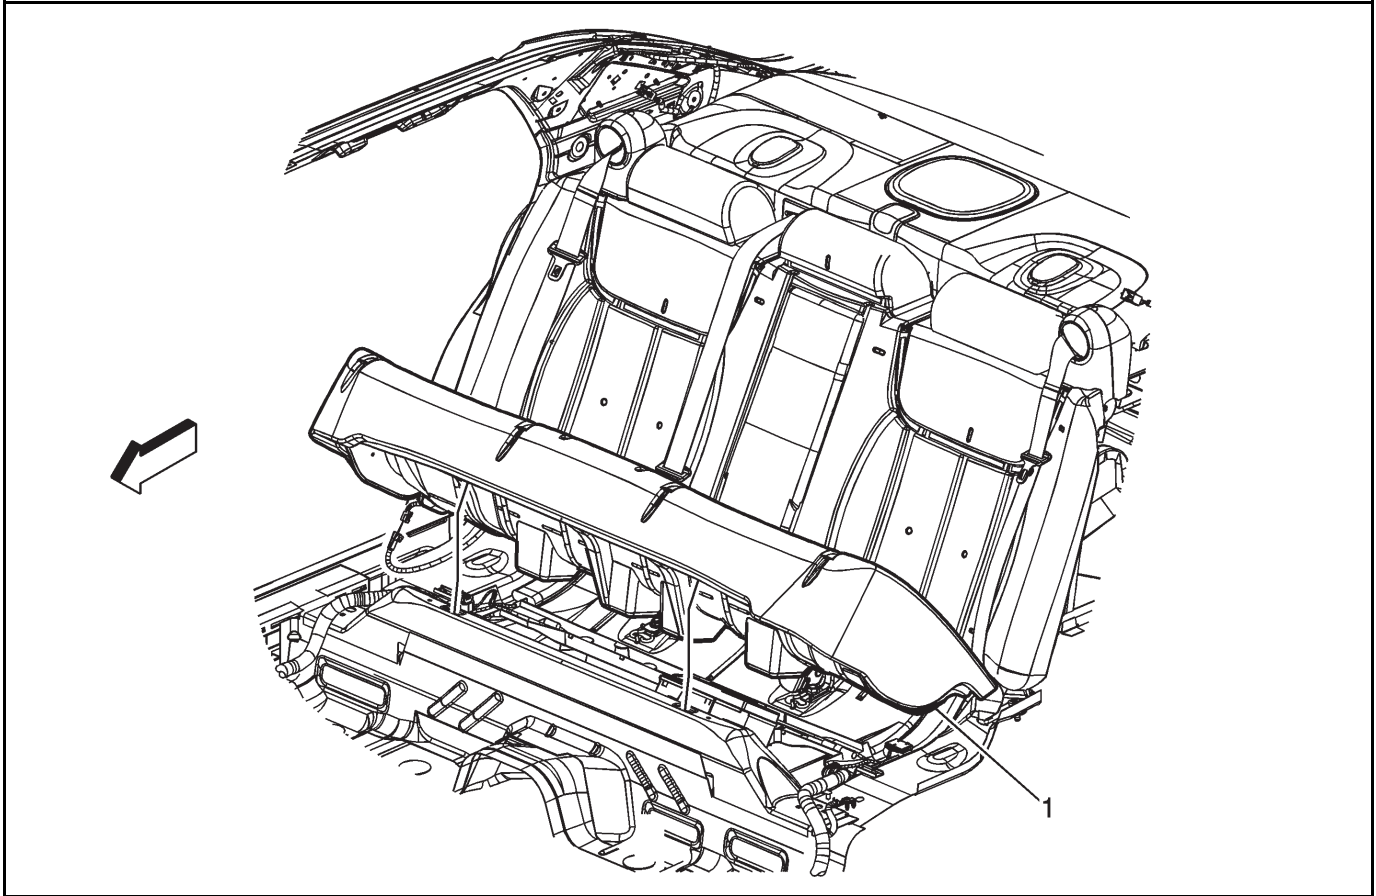
1572099

1. Remove the rear seat bottom cushion (1).
2. Disconnect the negative battery cable.

5. Remove and inspect the fuel pump relay (3) for any signs of contact, damage and/or burn marks.
6. Remove and inspect the fuel pump fuse (2) for any signs of damage and/or burn marks.
7. Separate the upper REC (6) from the lower housing (4) by pressing the 4 locking tabs.
8. Inspect the REC for the following concerns:

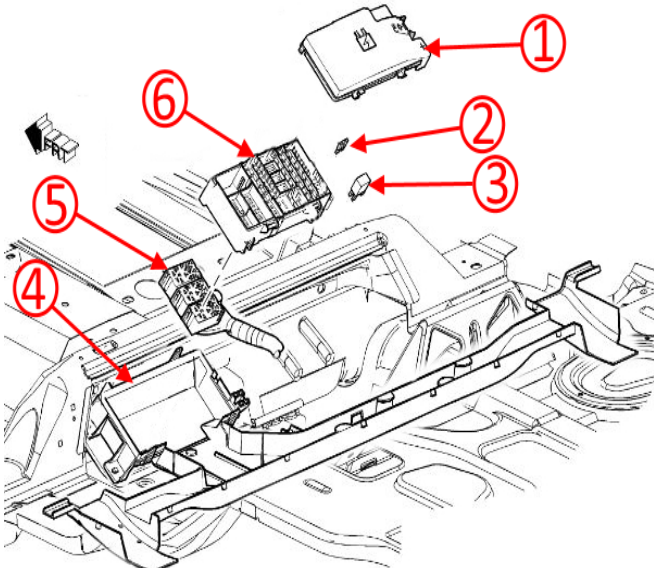
4871207

3. Remove the REC cover (1).
4. Inspect the cover for signs of contact with the fuel pump relay.

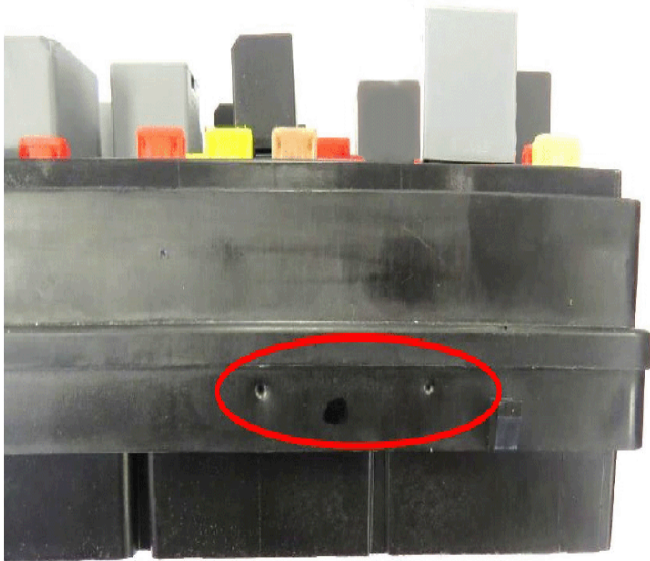
4871370

- Contact marks from the seat brackets. (Lucerne Only)

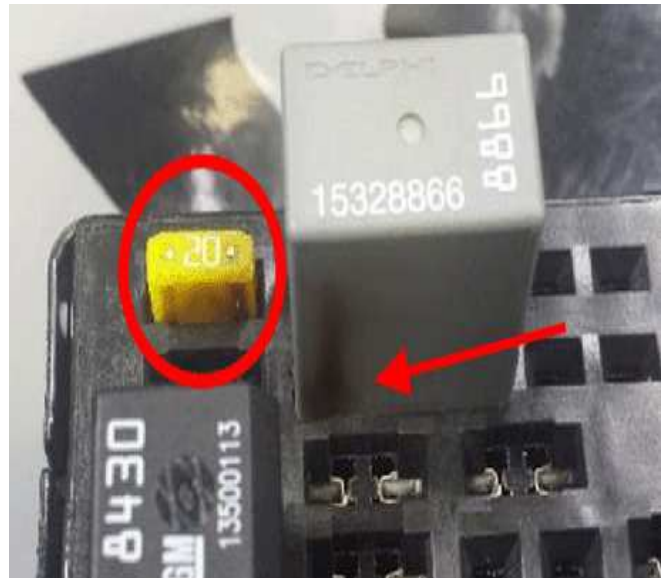
4871945

- Damaged and/or burnt X1 electrical connector.
9. Remove the X1 connector from the REC.

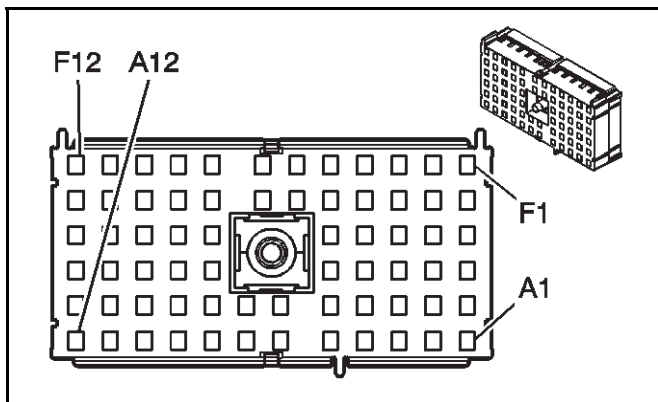
280787

- Burnt wires or terminals at the F1 cavity.

- Replace the REC.
- Repair the wire terminal at the F1 cavity.
- If required, replace the X1 connector.
- Trim seat brackets. (Lucerne Only)
- Re-position REC. (DTS Only)

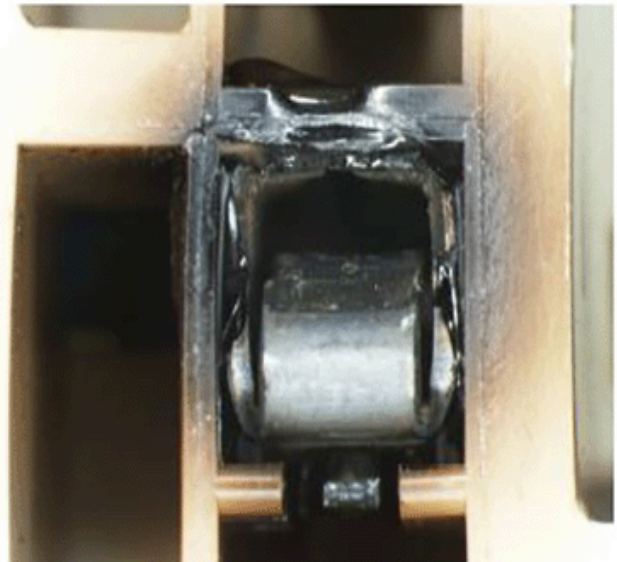
4871417

10. Inspect the connector for any damaged or burnt terminals.

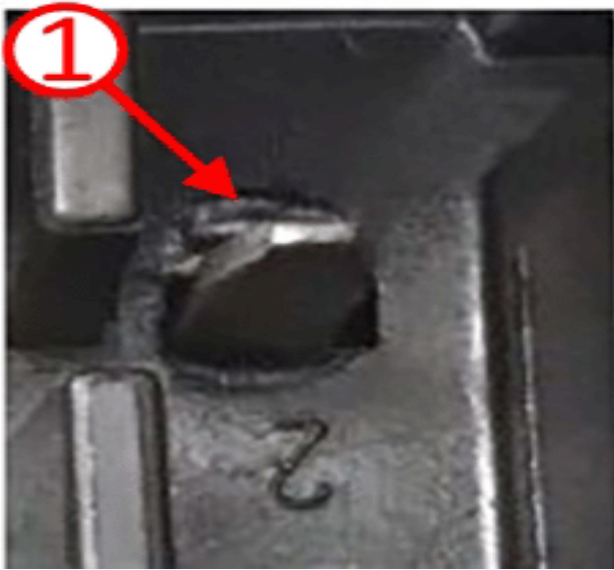
4871373

11. Inspect for any signs of warping or disfigurement caused by heat to the junction block (1).

If no damage is found, **Do Not** replace the fuse block and refer to SI for further diagnostics.

If damage was found, proceed with repair.
