Service Bulletin

Bulletin No.: 16-NA-051

Subject: Active Shutters Inoperative, Malfunction Indicator Lamp (MIL) Illuminated - DTCs P059F, P0071, P0072, P0073, P0074, P3056, U1345, U1501, U1510, U1511 Set

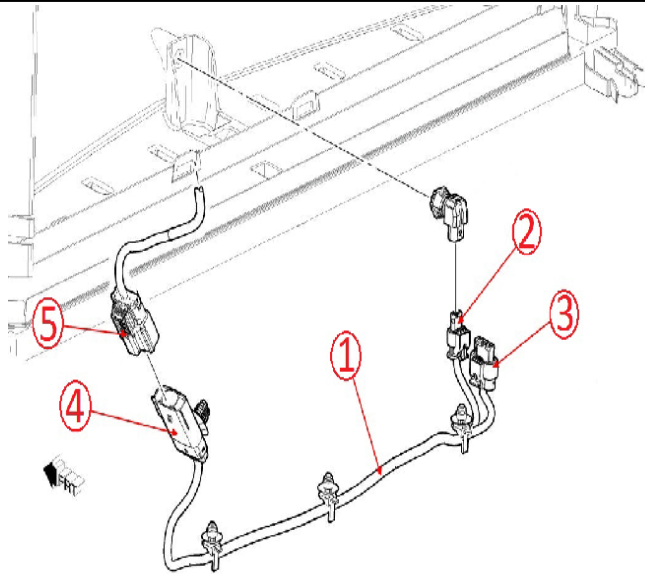
4527562

Inspect the ambient air temperature sensor wiring harness connectors B9 (2), M60B (3) and the X119 (4, 5) for any signs of corrosion.

Notice: The Ambient Air Temperature Sensor Wiring Harness must be replaced and dielectric grease must be applied to all of the connectors for any of the following repairs.

- If any signs of water and/or corrosion was found on the Ambient Air Temperature Sensor Wiring Harness (1), it must be replaced.
- If water and/or corrosion was found at the X119 connector (5), the main body wiring harness connector must be replaced.
- If water and/or corrosion was found at the B9 connector (2), the ambient air temperature sensor must be replaced.
- If water and/or corrosion was found at the M60B connector (3), the active shutter must be replaced.
