Service Bulletin

Bulletin No.: 16-NA-381

Subject: Head Restraint Material Coming Loose

Brand:	Model:	Model Year:		VIN:		Engine:	Transmission:
		from	to	from	to		
Buick	LaCrosse	2015	2016	SOP	September 9, 2016	All	All
Cadillac	XTS	2015	2017	SOP	September 9, 2016	All	All
Chevrolet	Impala (VIN 1)	2015	2017	SOP	September 9, 2016	All	All

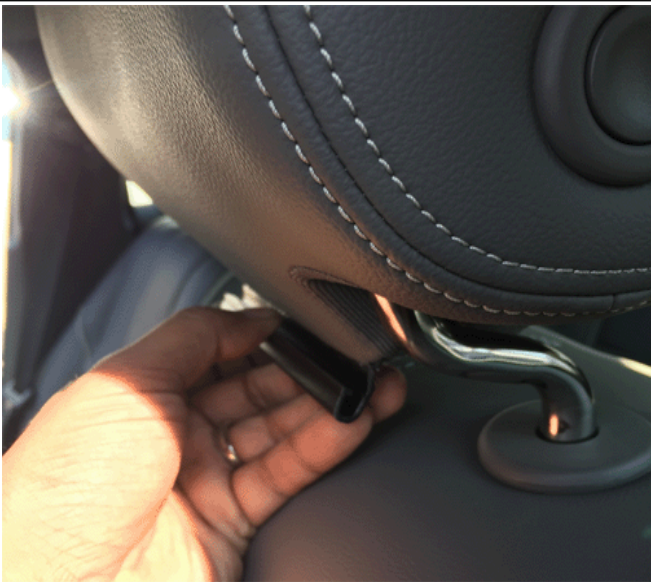
<p>4625426</p> <p>Some customers may comment that the material from the headrests is coming loose.</p>
Cause	This may be due to the J-clips not being robust enough to hold the material in place.
