# Service Bulletin

Bulletin No.: 17-NA-259

**Subject:** Body Creak Noise from Rear Seat Area

Brand:	Model:	Model Year:		VIN:		Engine:	Transmission:
		from	to	from	to		
Chevrolet	Camaro	2016	2018			All	All

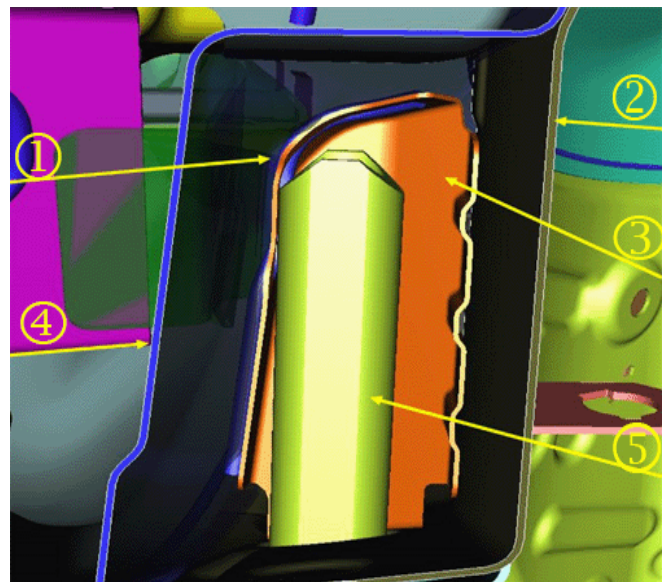
4880483

**Section View from Rear**

- (1) Structural Bond
- (2) Frame Rail Outer
- (3) Reinforcement Plate
- (4) Frame Rail Inner
- (5) Cradle Bolt Tube

**Note:** Most likely the reinforcement plate will be making contact at the top where it meets the frame rail inner. Care should be taken when drilling all holes, but especially when drilling the holes on top, not to drill into the reinforcement plate. The frame rail inner metal thickness is 1.2 mm.

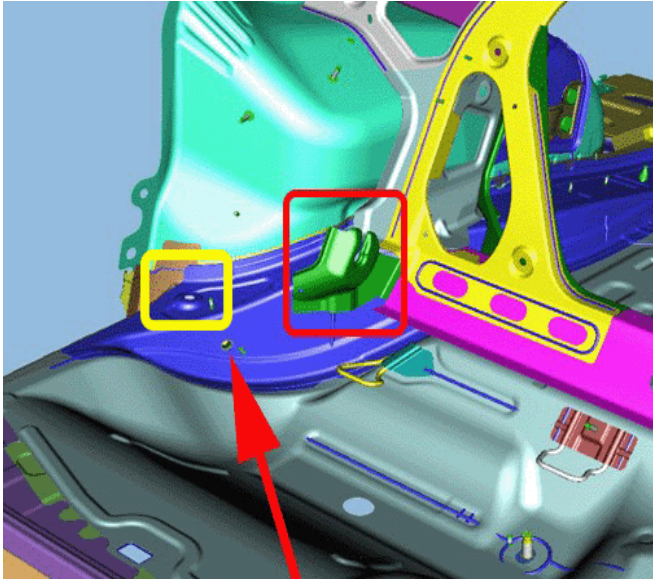
4880494

3. The frame rail inner has a plug (circled in yellow). This plug can be removed and the hole can be used to insert the bore scope.
4. Insert a borescope on the affected side, and fish the lens toward the contact point of the bracket illustrated in green above.

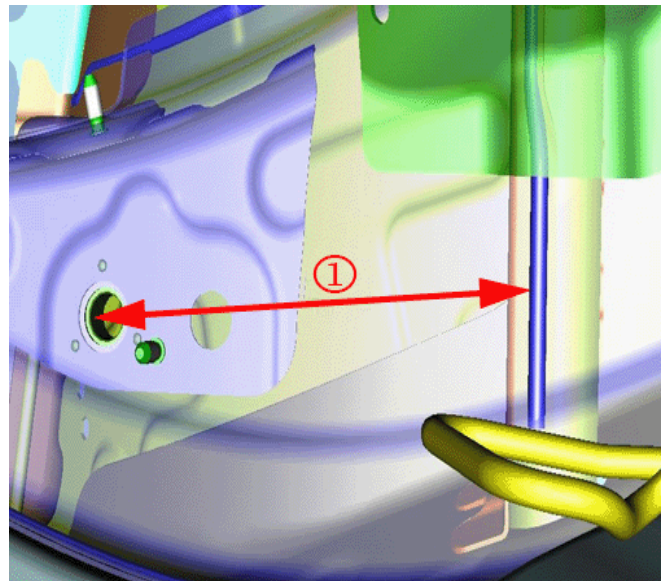
4880484

(1) 130.24 MM

6. If imperfections/voids are found, measure **130 mm** (make sure you see the edge of the reinforcement panel through the hole. If you look through the hole and see black, you've missed the panel) from the center of the lower rear seat belt retractor bolt hole to the bottom of the rear seat back cushion mount and mark with three X's, as illustrated above.
