# Service Bulletin

Bulletin No.: 17-NA-260

**Subject:** Seat Back Cushion Squeak Noise

| Brand: | Model: | Model Year: | | VIN: | | Engine: | Transmission: |
|---|---|---|---|---|---|---|---|
| Chevrolet | Bolt EV | 2017 | 2017 | | | All | All |

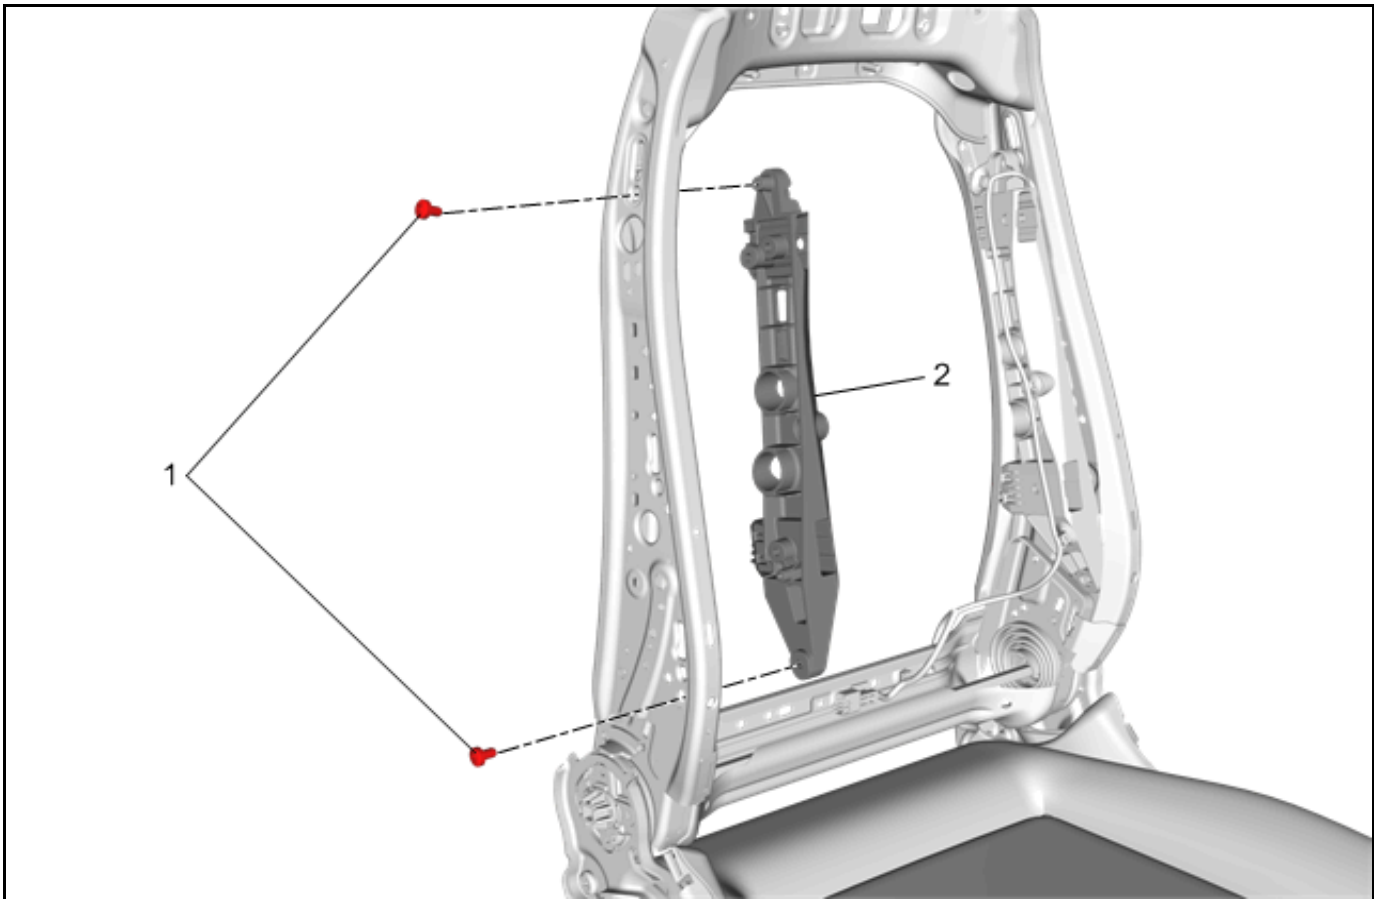
4538021

1. Follow the procedure to inspect the affected front seat back upper support. Refer to *Front Seat Back Upper Support Replacement* in SI.

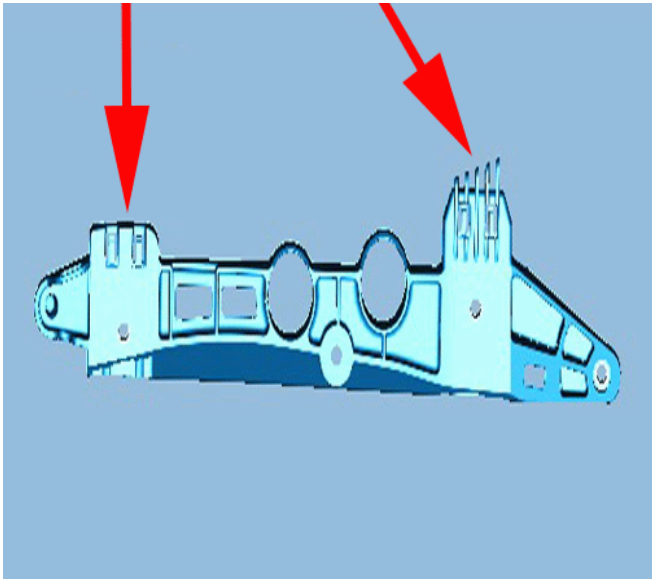
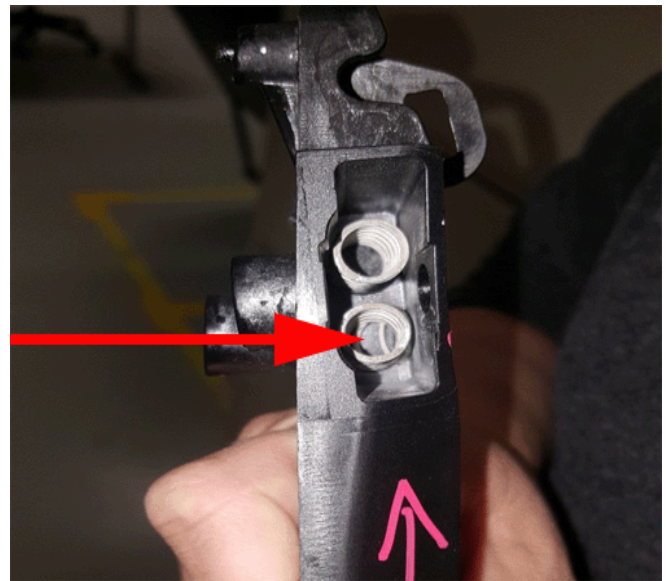
4898775

2. Inspect the support springs and for felt on the supports in the locations illustrated above.
- Inspect to verify that the springs in the supports are installed straight. Illustrated above is the bottom spring out of place. Replace the support and inspect the new support for felt.

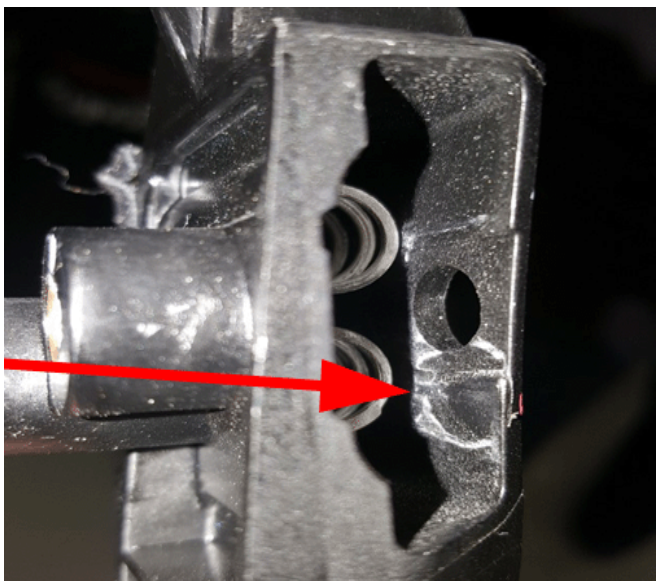
4898777

- Inspect the support for witness marks as illustrated above. Most likely the spring is bent. Replace the support and inspect the new support for felt.

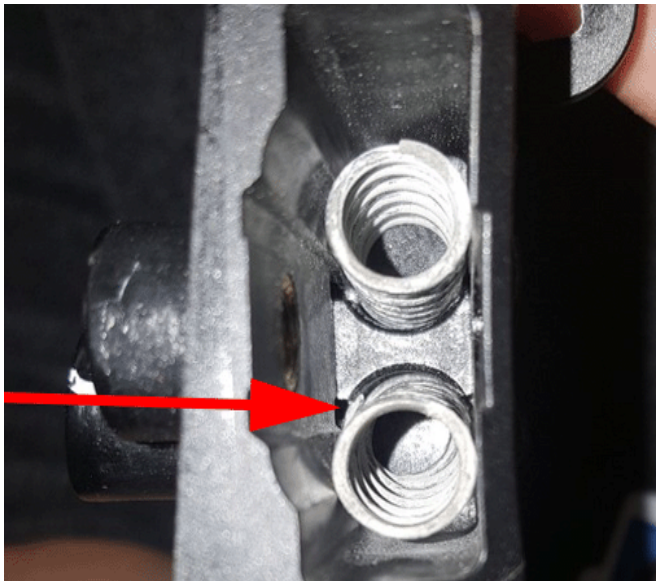
4898779

- Inspect the supports to verify that the springs are installed straight. Illustrated above shows the bottom spring out of place. Replace the support and inspect the new support for felt.
  - If felt is not observed, proceed to step 3.
3. To install the felt, remove the supports from the front seat back upper support.
