Service Bulletin

Bulletin No.: 17-NA-315

Subject: Head Lamp or Tail Lamp Inoperative

Brand:	Model:	Model Year:		VIN:		Engine:	Transmission:
		from	to	from	to		
Chevrolet	Trax	2017	2017

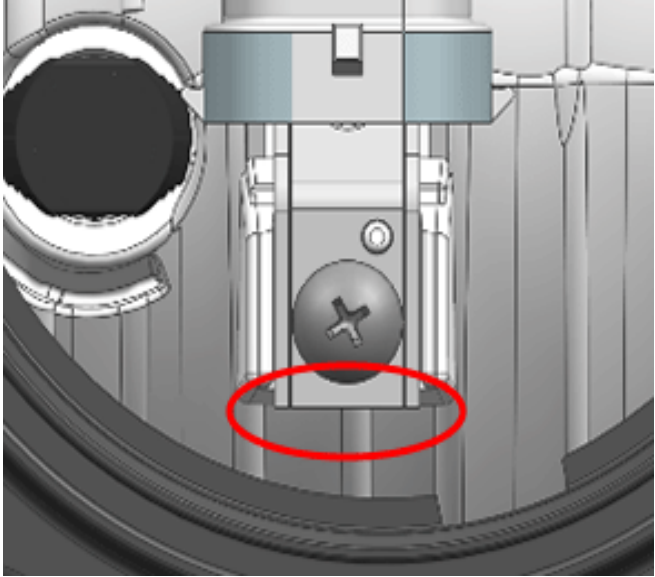
Involved Region or Country	North America and N.A.Exports
Condition	Some customers may comment that the head lamp and/or tail lamp may be inoperative. During diagnostics, the technician may find the head lamp fuse OPEN.
Cause	<div style="text-align: center;">

</div> <p style="text-align: right; font-size: small;">4873640</p> <p>This condition may be caused by an internal short in the head lamp wiring harness, contacting the reflector shield .</p>

Replace the Head lamp assembly, refer to Head lamp Replacement in SI.

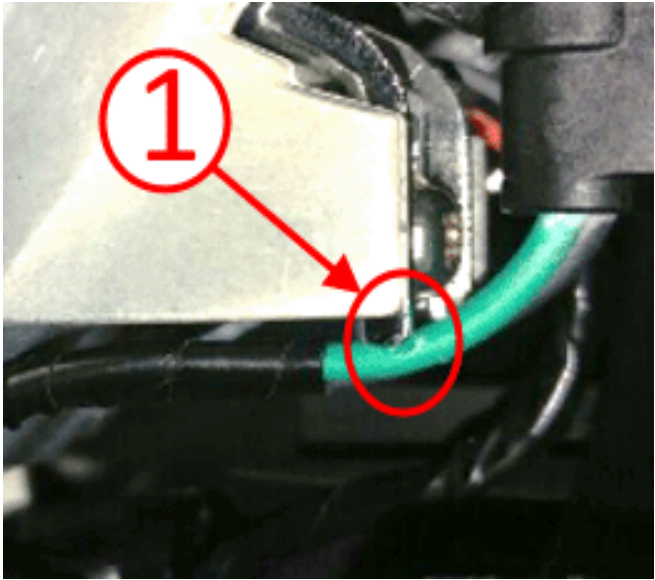
<p>4873265</p>	
<p>If you encounter a vehicle with the above concern, locate the front head lamp wiring harness at the head lamp bulb and validate chaffing against the reflector shield.</p>
