# Service Bulletin

Bulletin No.: 17-NA-318

**Subject:** Door Trim Panel Gap Along Top After Front or Rear Trim Panel Installation

| Brand: | Model: | Model Year: | | VIN: | | Engine: | Transmission: |
|---|---|---|---|---|---|---|---|
| Chevrolet | Bolt EV | 2017 | 2017 | | | All | All |

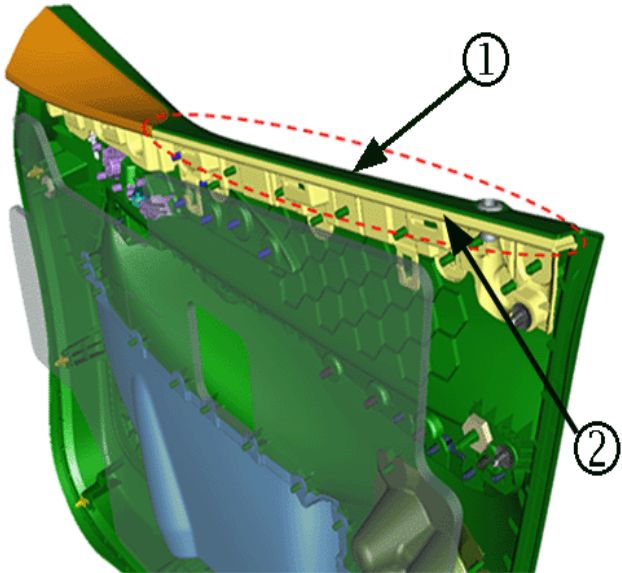
| Involved Region or Country | North America, Europe, Korea, Middle East |
|---|---|
| Condition | <p>4875529</p> <p>Some customers or technicians may comment on seeing a gap between the top pad trim (1) and support panel (2) on a front or rear door trim panel. The condition is most common after the trim panel has been installed during a repair.</p> |
| Cause | The cause of the condition may be that during a repair, the door pad top trim piece can become unseated when the door pad is pulled off of the clips that secure the door trim panel to the door. |

**Do not replace the door panel for this condition.** The gap can be eliminated by firmly pressing down and fully seating the top trim on the door panel.
