# Service Bulletin

Bulletin No.: 17-NA-347

**Subject:** Diagnostic Tip for Right and/or Left Rear Turn Signals Flashes too Fast

| Brand: | Model: | Model Year: | | VIN: | | Engine: | Transmission: |
|---|---|---|---|---|---|---|---|
| Chevrolet | Traverse | 2018 | 2018 | | | | |

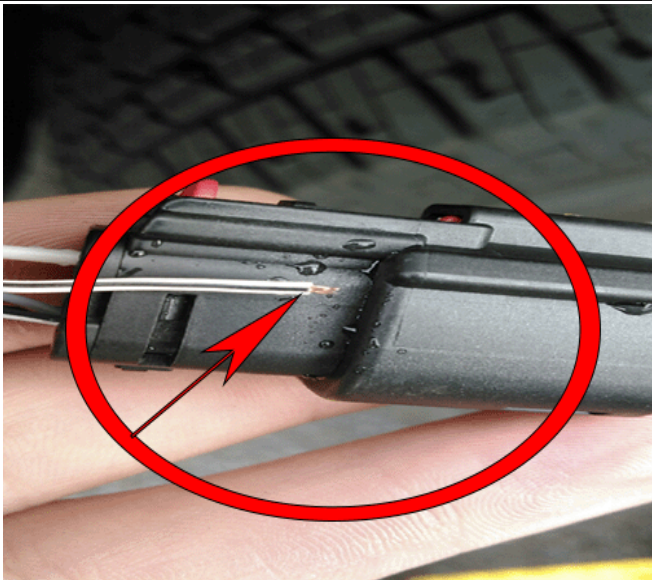
| | This condition may be caused when terminal #3 in the tail lamp connector being pulled out of the connector, or the wire being broken at the crimp.<br><b>Note:</b> In some cases the wire is broken internal to the insulation. |

| <b>Correction</b> | Replace the tail lamp harness. |
