Service Bulletin

Bulletin No.: 17-NA-226

Subject: Clicking and/or Popping Noise While Turning Steering Wheel Lock to Lock

Brand:	Model:	Model Year:		VIN:		Engine:	Transmission:
		from	to	from	to		
Cadillac	CT6	2016	2018

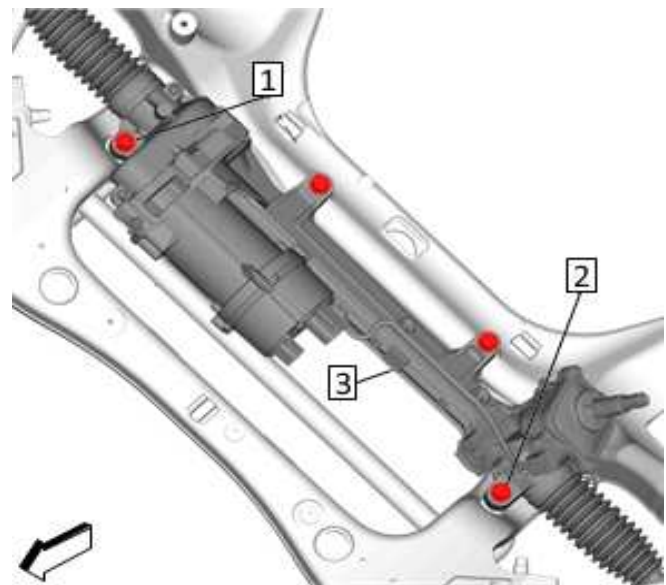
4830353

Involved Region or Country	North America and N.A. Export Regions
Condition	Some customers may comment on hearing a clicking and/or popping noise when they are turning the steering wheel from lock to lock, and the noise can be heard when the vehicle is stationary.
Cause	This condition may be caused by insufficient torque load on the front two steering gear to cradle bolts.
Correction	If the noise can be validated to be coming from steering gear movement, the front steering gear bolts must be replaced with new bolts and torqued to specifications.

1. Remove the front tires. Refer to *Tire and Wheel Removal and Installation* in SI.
2. Starting with the driver side, remove the steering gear front cradle bolt (2) and discard.
3. Using a flex head torque wrench, torque the new bolt to 58 N•m (43 lb ft) plus 35 to 40 degrees.
4. Repeat the steps for the passenger side bolt (1).
