# Service Bulletin

Bulletin No.: 17-NA-246

**Subject:** Outer Window Belt Moldings Poor Fit and Retention

Brand:	Model:	Model Year:		VIN:		Engine:	Transmission:
		from	to	from	to		
Chevrolet	Equinox	2018	2018			All	All
GMC	Terrain	2018	2018			All	All

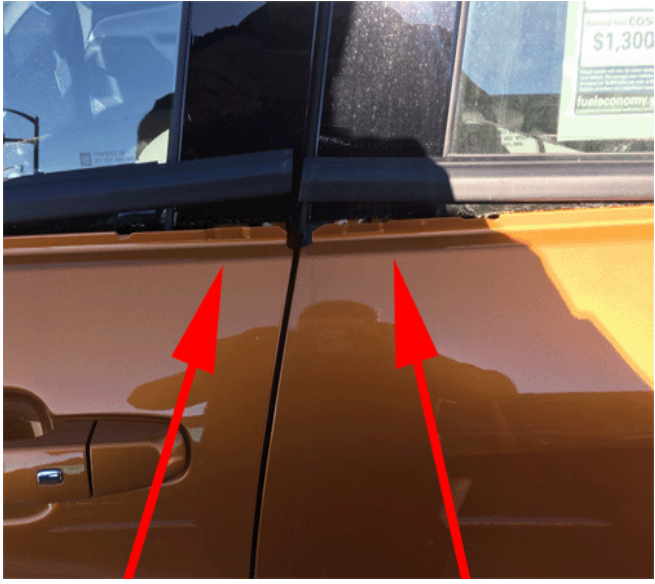
<p>4840370</p> <p>Some customers may comment on poor fit and retention of the outer window belt moldings to the doors.</p>

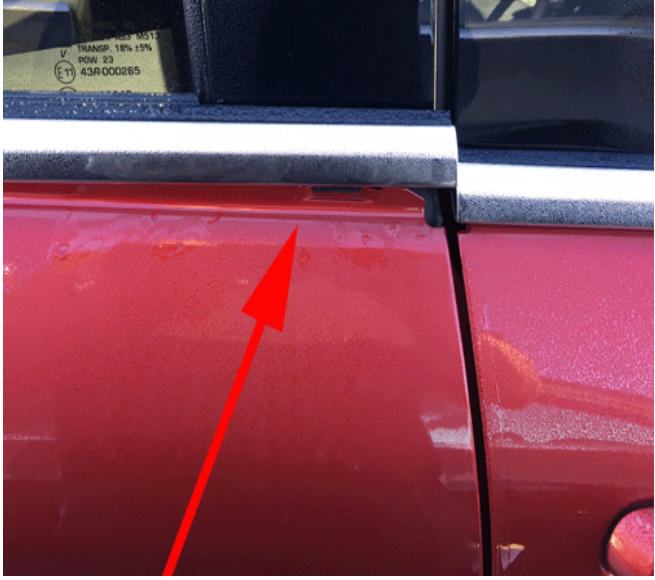
<p style="text-align: right;">4840369</p> <p><b>Note:</b> This condition can occur on any of the four doors and can occur on black or chrome moldings.</p>
<p><b>Cause</b></p>	<p>This may be caused by the original molding design not providing the proper fit to the door surface.</p>
<p><b>Correction</b></p>
