# Service Bulletin

Bulletin No.: 17-NA-258

**Subject:** Excessive Wind Noise from Front Side Door Glass Area

Brand:	Model:	Model Year:		VIN:		Engine:	Transmission:
		from	to	from	to		
Chevrolet GMC	Silverado 1500 Sierra 1500	2014	2014			All	All
Chevrolet GMC	Silverado Sierra	2015	2018

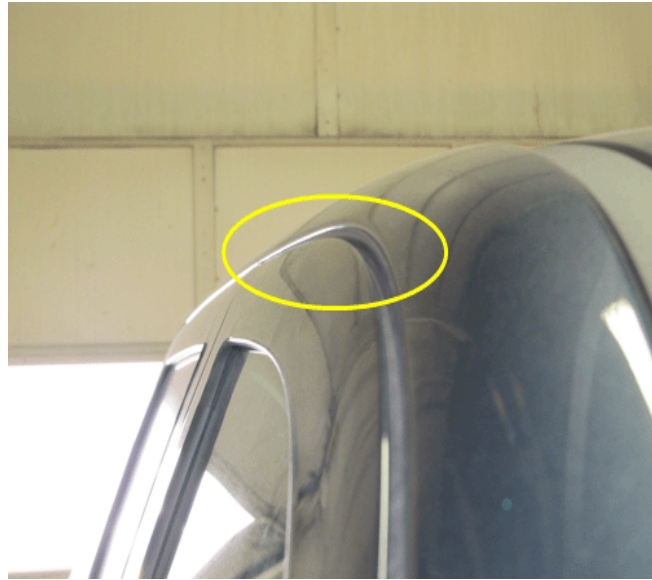
3806381

- Improper front side door fit to roof.

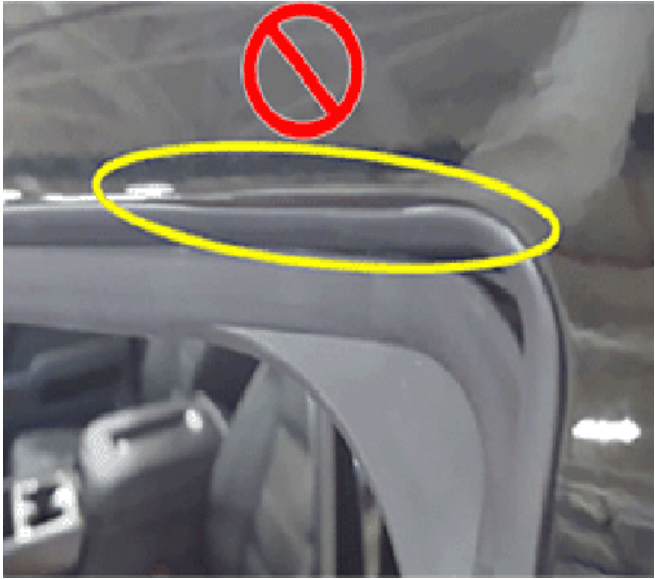
<p style="text-align: right;">4846276</p> <ul style="list-style-type: none"> <li>• Incorrectly installed front side door window weatherstrip.</li> <li>• Wind noise generated from sheet metal openings in the upper door frame.</li> </ul>
<p><b>Correction</b></p>	<p><b>Note:</b> In cases where the noise can't be verified coming from the door, and may be coming from the rear cab area, see Bulletin #17-NA-151.</p> <p>Verify the condition and repair following the steps outlined in the Service Procedure below.</p>

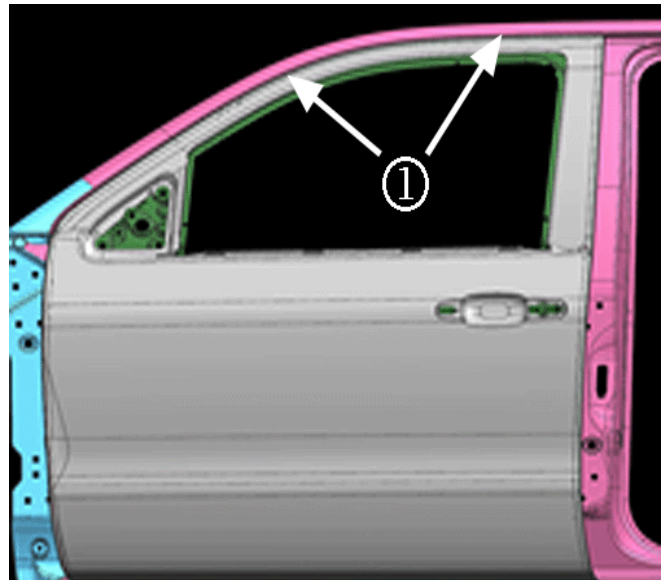
**Note:** These vehicle models use an inlay door construction, with the door fitting sub-flush to the body header by 1-2 mm (0.040–0.080 in).

1. At the two locations (1) shown in the illustration above, inspect the front door fit as to meeting the suggested 1-2 mm (0.40–0.80 in) sub-flush dimension.
  - If the door fit meets the sub-flush specification, no door adjustment is necessary and you can jump ahead to step #4.
  - If the door fit DOES NOT meet the sub-flush specification, continue to step #2 to start the door adjustment.

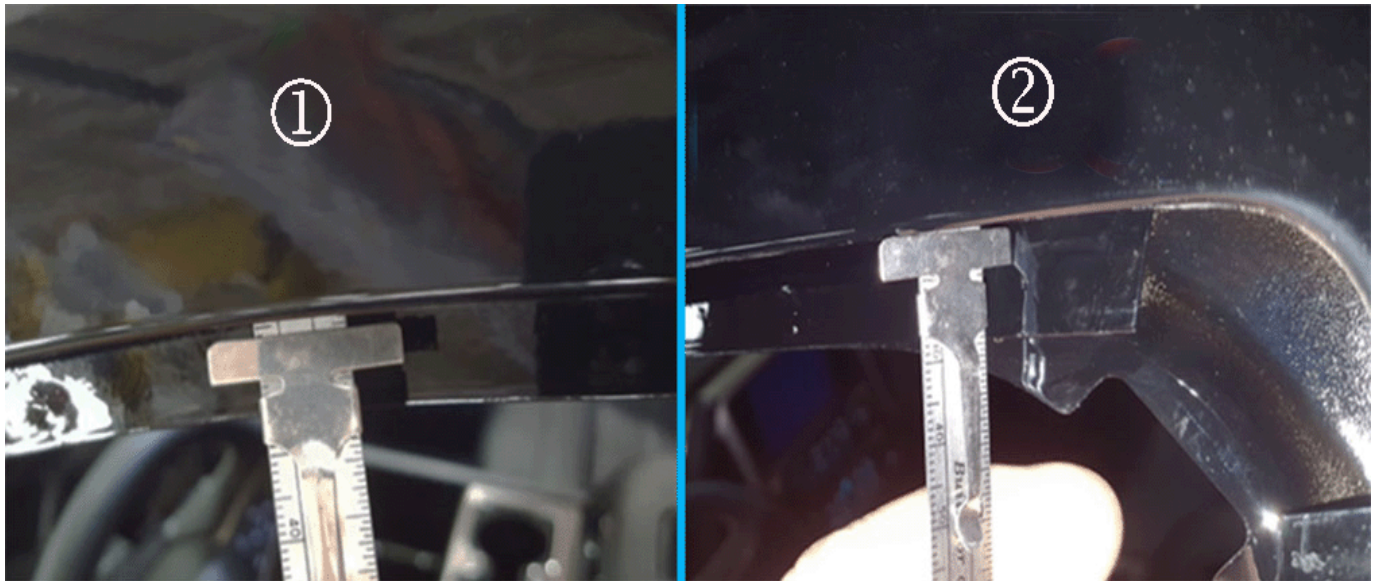
4846289

- 6.7. Inspect the upper door frame metal glass run channel, just forward of the B pillar, for possibly being out of design location.
- If the metal run channel is approximately the same depth across the top (1), no additional repair in this area is needed, and you can move ahead to step # 8.
  - If the metal run channel is approximately 1.5 mm higher (up/down) (2), continue to step # 7 to add foam tape.

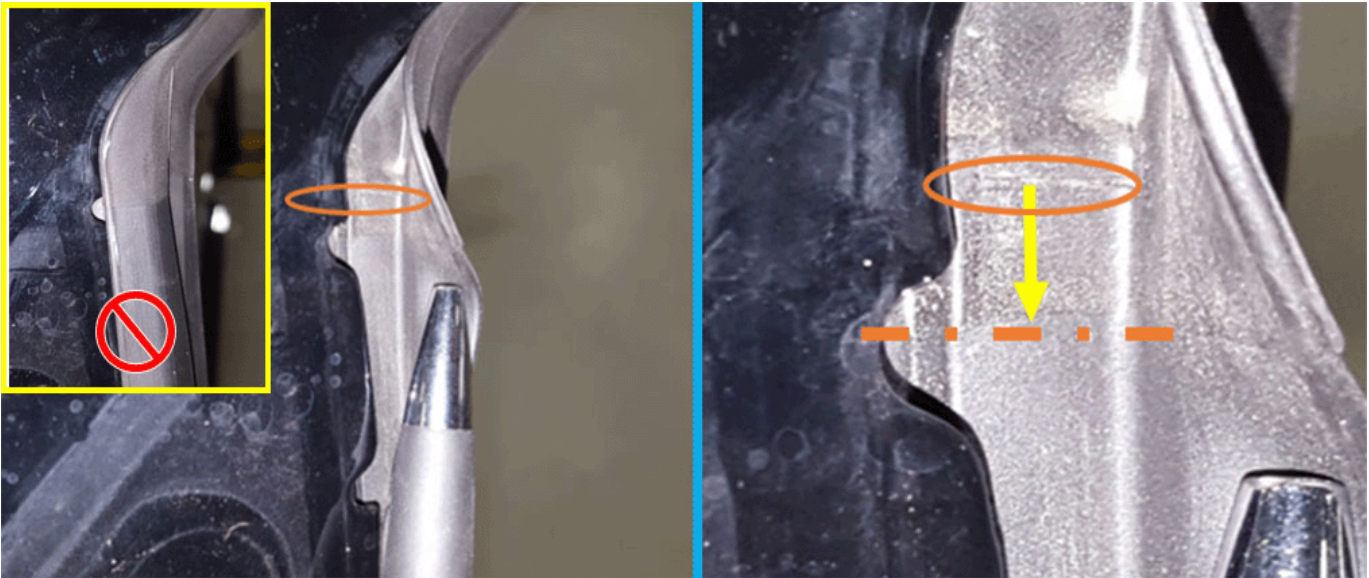
4846295

**Important:** The last example above shows the front, upper corner of the weatherstrip installed too high and well out of position. The feature line (shown circled) should be located down at the center-line of the metal notch.
