Service Bulletin

Bulletin No.: 17-NA-371

Subject: Sunshade Auto Open Feature Noisy or Inoperative, and/or Sunshade Latch Handle Broken

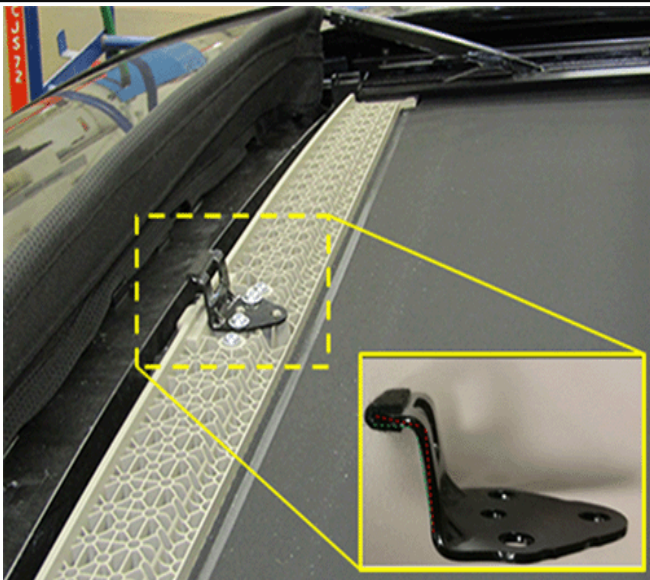
<p>4900559</p> <p>The cause of the condition may be that the sunroof sunshade auto open bracket may cause noisy operation or a broken latch handle during opening, if the sunshade is left closed.</p>

Involved Region or Country	North America, N.A. Export Regions
Additional Options (RPOs)	Equipped with ROOF-SUN, GLASS, SLIDING, ELEC, TRANSPARENT GLASS FIXED (C3U).
Condition	<p>Some customers may comment on the following:</p> <ul style="list-style-type: none"> For 2017, and some early 2018 model year vehicles, the front sunshade latch handle may be noisy or broken when the sunroof is opened without opening manual shade first. For 2018 model year vehicles, the front sunshade latch handle may be noisy or broken when the sunroof is opened without opening the manual shade first, or not functioning at all.
Cause

Verify the condition, remove the sunshade auto open bracket and replace the latch handle ONLY (if broken), following the Service procedure below.
