Service Bulletin

Bulletin No.: 17-NA-373

Subject: Malfunction Indicator Lamp (MIL) Illuminated and DTC P0071 Set at PDI

Brand:	Brand: Model:		Model Year:		VIN:		Transmission:
Біапи.	woder.	from	to	from	to		
Buick	Encore	2017	2017			LE2	All

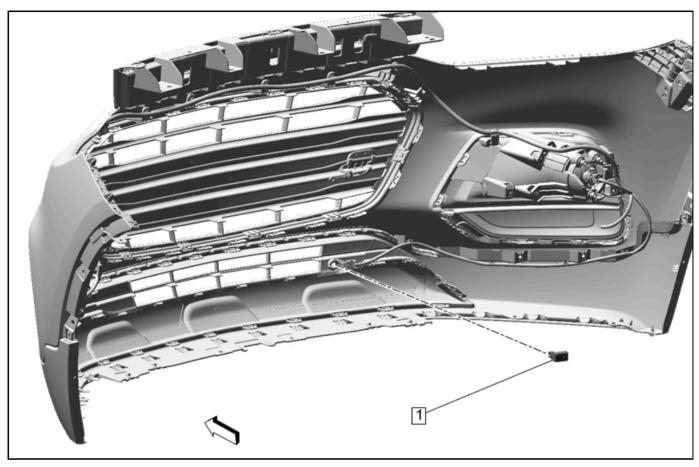
4531838

Involved Region or Country	North America and N.A. Export Regions	
Additional Options (RPOs)	Equipped with 1.4L Turbo 4 Cylinder Engine (RPO LE2)	
Condition	Some technicians may notice a malfunction indicator lamp (MIL) illuminated at PDI. During diagnosis, a technician may find DTC P0071 set in the engine control module.	
Cause	This may be due to the vehicle being built with the incorrect ambient air temperature sensor.	
Correction	Replace the ambient air temperature sensor.

If you encounter a vehicle with the above concern, remove and inspect the ambient air temperature sensor. Refer to *Ambient Air Temperature Sensor Replacement* in SI.

- If the part number on the ambient air temperature sensor is 13583411, continue diagnosis referring to SI.
- If the part number is anything other than part number 13583411, replace the sensor.
