## **Service Bulletin**

Bulletin No.: 17-NA-380

**Subject:** Rattle Type Noise Heard from Underneath Vehicle

Brand:	Model:	Model Year:		VIN:		Engino	Transmission:
		from	to	from	to	Engine:	
Chevrolet	Equinox	2018	2018				
GMC	Terrain

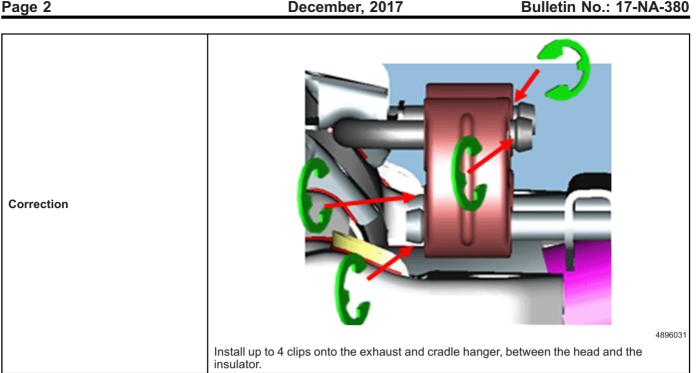
Involved Region or Country  North America and N.A. Export Regions			
Condition	Some customers may comment on a rattle type noise heard from underneath the vehicle.		
Cause	This condition may be caused by the isolator (1) being separated from the cradle hangers (2).	4895575

Labor Operation	Description	Labor Time
4081948*	Installing Clips onto the Exhaust and Cradle Hanger	0.3 hr
*This is a unique Labor Operation for Bulletin use only.
