## **Service Bulletin**

Bulletin No.: 17-NA-152

Subject: Front Seat Slight Rocking Movement While Shifting Weight from Seat, During Hard Stops, and/or When Driving Over Rough Road Surface

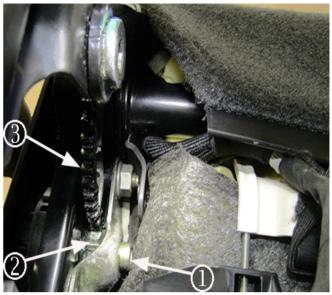
4789333

**Note:** The intent on applying a load to the pinion shaft (1) is to force full gear mesh, and lessen any teeth clearance between the gear on the actuator (2) and the sprocket (3) on the seat track, reducing seat movement.
