Service Bulletin

Bulletin No.: 17-NA-358

Subject: Gap Between Upper Dash Pad and Center Stack

Brand:	Model:	Model Year:		VIN:		Engine:	Transmission:
		from	to	from	to		
GMC	Terrain	2018	2018			All	All

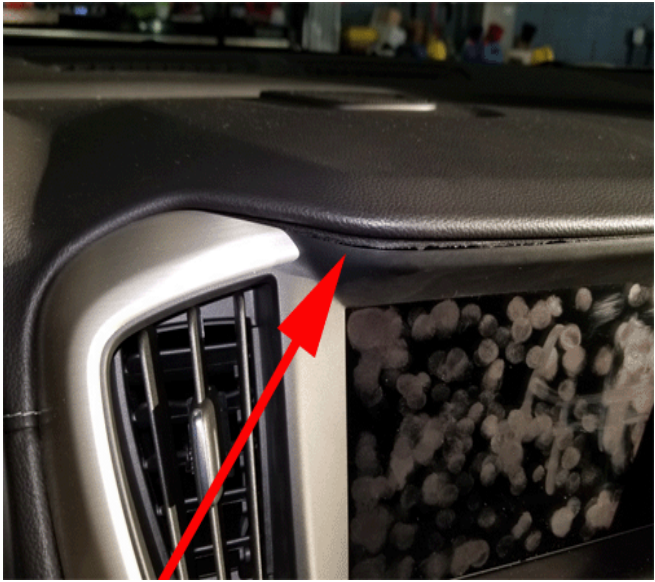
<p style="text-align: right;">4887509</p> <p>Some customers may comment on a GAP between the upper dash panel and the center stack.</p>
Cause	This may be due to a fit issue between the dash panel and integrated center stack.
Correction	Rework the radio control assembly and re-install.

1. Remove the radio control assembly. Refer to *Radio Control Assembly Replacement* in SI.
2. Once the radio control assembly is removed, remove the two metal retainers at the top of the radio control trim.

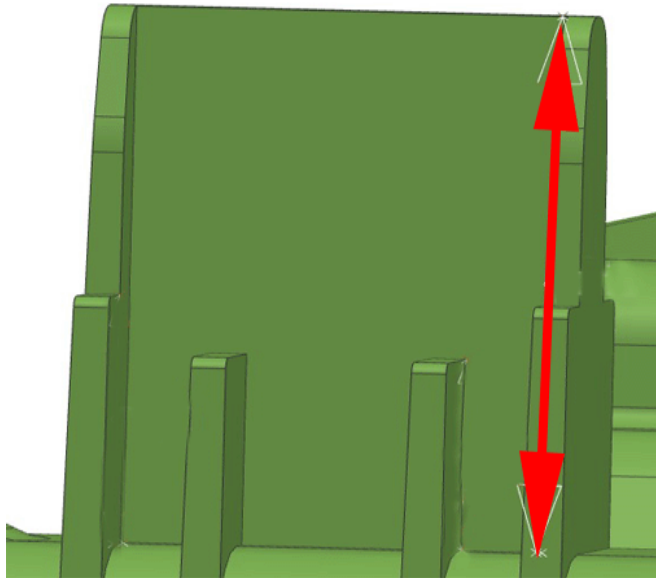
4887512

3. Measure the tab in which the retainers were removed from as illustrated above. If the tabs are 25 mm or longer, continue to Step 4. If the tabs are not 25 mm, continue diagnosis referring to SI.
