Service Bulletin

Bulletin No.: 17-NA-364

Subject: Rattle Noise Originating from Driver Side Rear Seat

Brand:	Model:	Model Year:		VIN:		Engine:	Transmission:
			from	to	from	to		
	Buick	Envision	2015	2018			All	All

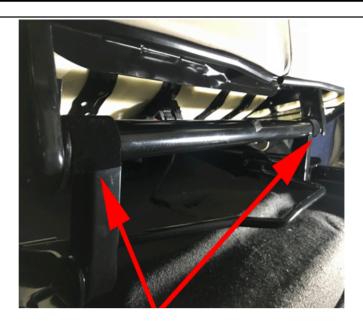
4894051

Involved Region or Country	North America and China		
Condition	Some customers may comment on a rattle type noise originating from the driver side rear seat. This may be due to the cushion side member touching the frame tube creating a rattle type noise.		
Cause			
Correction	13 08 20 B		
	4804

Add felt tape to the frame tube.
