# Service Bulletin

Bulletin No.: 17-NA-405

**Subject:** Intermittent White or Black Radio Screen When Starting Vehicle and/or Radio Resets Shortly After Start-Up with a Phone Paired

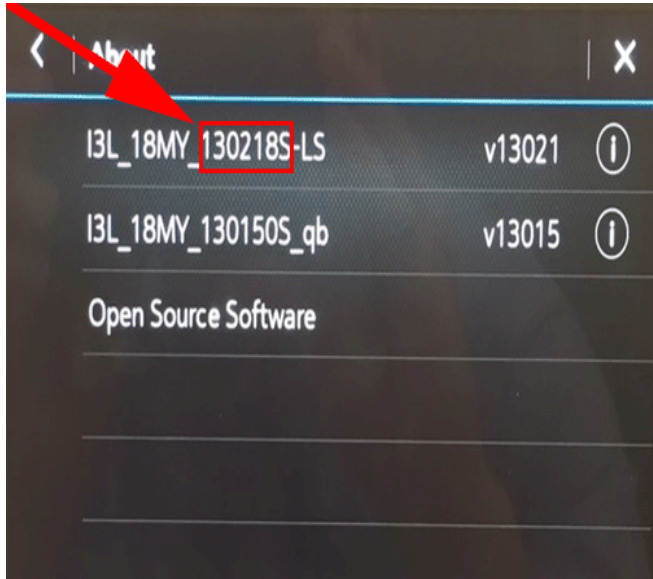
4923191

If it is not possible to determine which contact or address is causing the radio reset due to a large number of stored contacts or if the white/black radio screen complaint is reported, check the software version of the radio to determine next steps. This can be done by selecting the following path from the radio display: Settings > Systems Tab > About. The About screen will then appear and show the current SW version of the radio on the top line as shown in the illustration below. The red outline in the illustration below is the software version.

If the software version is 131155 or newer/greater, the radio already contains improvements to address the issues described in this bulletin so normal SI diagnosis should be followed.

If the software version is older/lower than 131155 like in the example below, replace the radio and re-evaluate the concern(s). Refer to Radio Replacement in Service Information for detailed instructions.
