# Service Bulletin

Bulletin No.: 17-NA-204

**Subject:** Fuel Leak, Fuel Smell/Odor, Rubbing/Grinding/Clanking/Hitting/Banging/Popping/Thumping Noise from Under Vehicle, Fuel Gauge Reading Inaccurate - DTC's P0461, P462, P0463, P2067, P2066, P2068 and P2636 Set

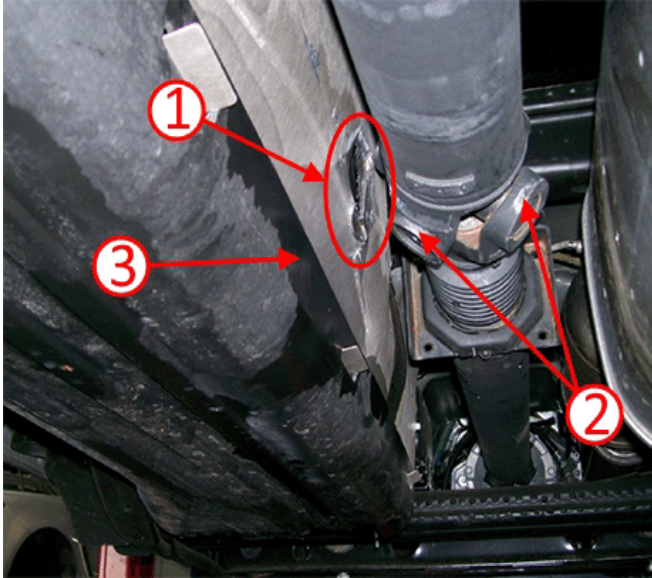
4823613

<p><b>Cause</b></p>	<p>This condition may be caused by the front level sender failing to register fuel transfer properly causing the transfer pump to continuously transfer fuel to the fuel tank, causing the tank to expand past its specifications resulting in one or both of the following:</p> <ul style="list-style-type: none"> <li>On gasoline powered vehicles, fuel forced into the evaporative emissions system.</li> </ul>

<p>⇒ All fuel driven vehicles, the drive shaft (2) may contact the aluminized steel shield (1) on the inboard side of the fuel tank creating noises as it grinds a hole through the shield and through the plastic fuel tank resulting in a fuel leak (3).</p>
<p><b>Correction</b></p>	<p>If the fuel tank has been validated to be the cause of the conditions listed, replace the front fuel tank, shield, pump and level sender.</p>
