Service Bulletin

Bulletin No.: 17-NA-362

Subject: Diagnostic Tip for Misaligned Rear View Camera Gridlines

Brand:	Model:	Model Year:		VIN:		Engine:	Transmission:
		from	to	from	to		
Chevrolet	Equinox	2018	2018	SOP	September 11, 2017

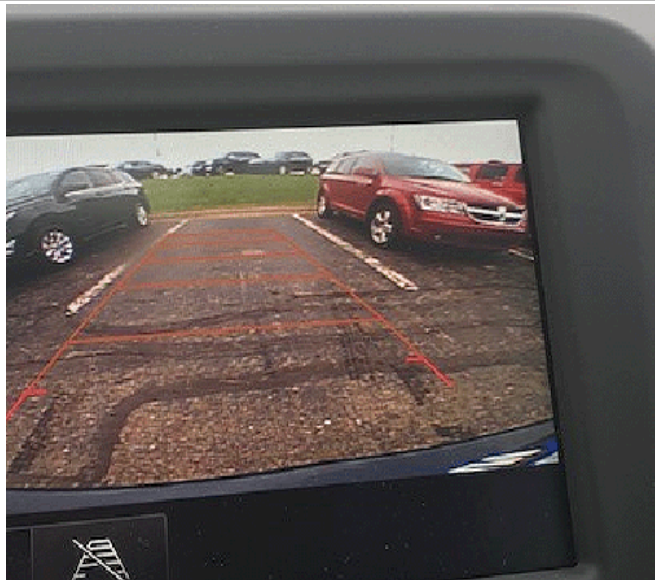
<p style="text-align: right; font-size: small;">4897753</p> <p>Some customers may comment on the rear view camera gridlines not being aligned properly and gives an inaccurate indication of the vehicle path.</p>
Cause	This condition may be caused by a software anomaly.
Correction	SPS program the radio with the latest TIS2 Web Calibrations, which are designed to correct this issue. The rear camera calibration description should read: " New calibrations to correct rear camera guidelines."

SPS program the radio with the latest TIS2 Web calibrations, USB programming will not fix this issue.
