Service Bulletin

File in Section: -
 Bulletin No.: 17-NA-387
 Date: December, 2017

Subject: Front Seatbelt Latch Plate Reversed, Front Seatbelt Twisted

Brand:	Model:	Model Year:		VIN:		Engine:	Transmission:
		from	to	from	to		
Buick	Envision	2016	2018			All	All

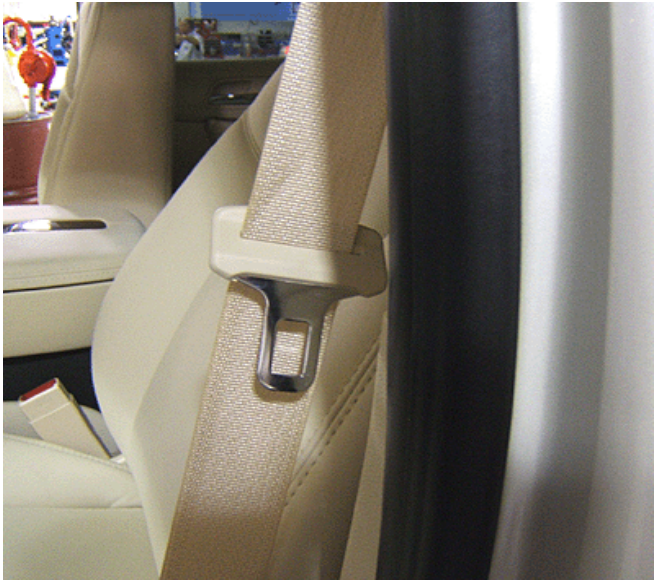
<p style="text-align: right;">1992083</p> <p>Some customers may comment that the seatbelt latch plate is reversed on the belt webbing or that they have to twist the webbing before buckling the seatbelt. This condition can be visually verified by inspecting the location of the latch plate tongue. If the tongue is between the webbing and the pillar post, it is reversed.</p>
Cause	The cause of the condition may be that during pulling or retracting of the seatbelt, the belt material may become folded over. If the seatbelt latch plate is then pulled upward and past the folded over material, it will reverse the latch plate tongue to the wrong side of the belt.
Correction	Do NOT replace the seatbelt retractor for this condition. To correct this condition, perform the following service Procedure repair below.

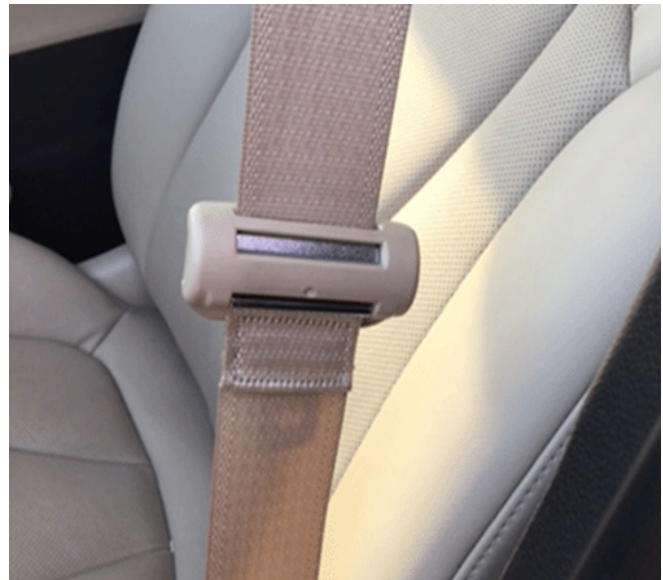
4914169

When in the correct location, the latch plate tongue will be between the webbing and the seat.

2. With the latch plate resting at its lowest point, take the webbing above the latch plate and fold the webbing over itself at a 45 degree angle. Pinch the folded portion between the thumb and forefinger.
3. Using the other hand, pull the latch plate up over the fold until past the doubled over section.
