Service Bulletin

Bulletin No.: 16-NA-118

Subject: Engine Wiring Harness Chafing, No Start or Malfunction Indicator Lamp (MIL) ON

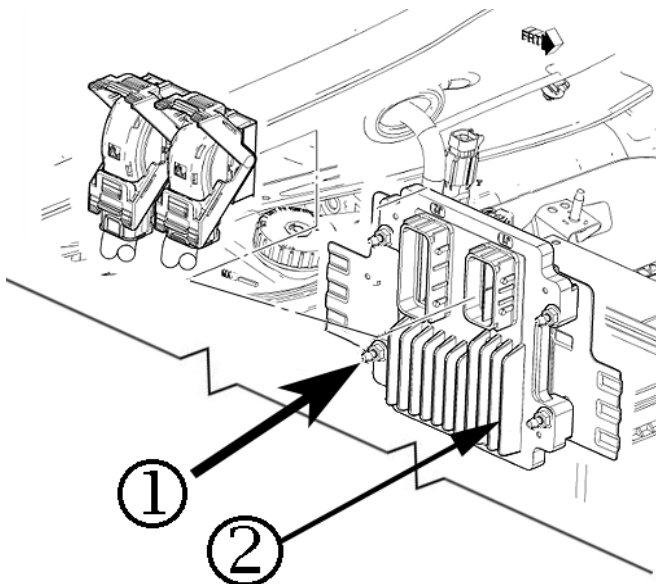
4571953

Involved Region or Country	North America
Condition	Some customers may comment on various conditions such as; no start, Malfunction Indicator Lamp (MIL) ON, and possible loss of steering assist.
Cause	Technicians may find the engine harness routed too close to the ECM lower mounting bracket stud or the corner of the ECM. The stud or corner can pierce the harness, and chafe and short wires inside the harness.
Additional Options	Equipped with 1.8L L4 LUW, 1.8L L4 LWE, 1.4L LUV or 1.2L LLO engine

ECM Mounting Bracket Stud (1) and Corner of ECM (2) Contact Area
