Service Bulletin

Bulletin No.: 16-NA-175

Subject: Shake and/or Shudder During Light Throttle Acceleration Between 25 and 80 MPH (40 and 128 KM/H) at a Steady State

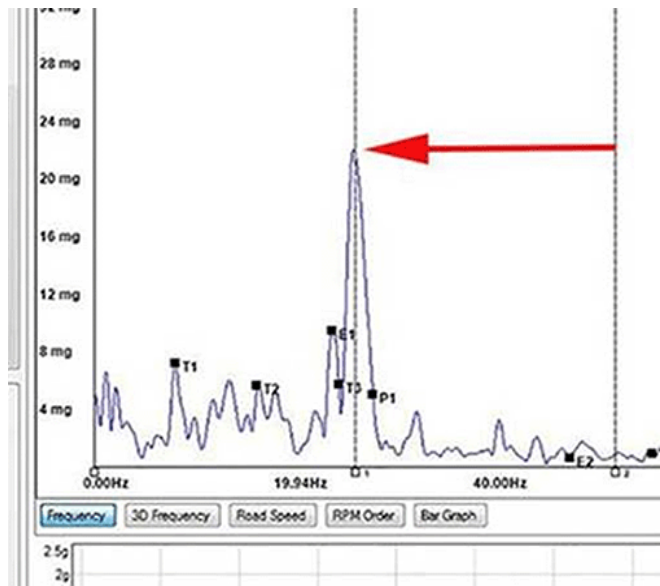
To confirm TCC Shudder, record the PicoScope data while driving in 8th gear in the application specific condition above. Minimize extraneous vibration input by testing on a smooth road and correct any other known vehicle vibration issues (tires, brakes, etc.) before conducting test. If TCC Shudder is present, a vibration peak will appear (highlighted by arrow below) within +/-2 Hz of the frequency listed in the table above. TCC

Shudder vibration frequency is stationary in 8th gear. If the vibration frequency follows vehicle speed or engine speed, then it is NOT TCC Shudder.

In the above illustration, frequency and default view have been selected.
