# Service Bulletin

Bulletin No.: 16-NA-327

**Subject:** Instrument Panel (IP) Rattle or Buzz Noise

Brand:	Model:	Model Year:		VIN:		Engine:	Transmission:
		from	to	from	to		
Chevrolet	Cruze (VIN B)	2016	2017			All	All

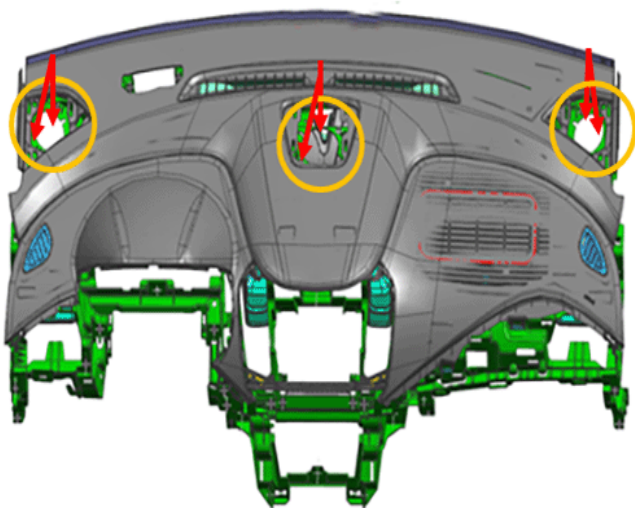
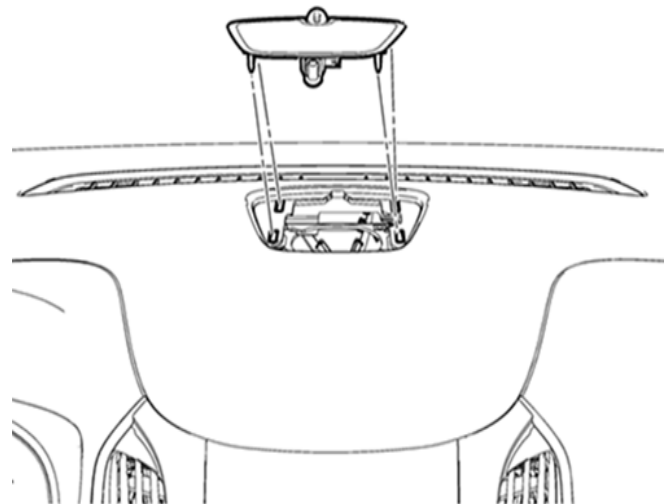
<b>Involved Region or Country</b>	North America, South America, Israel
<b>Additional Options (RPO)</b>	Equipped with Speaker System - Standard Audio (RPO UQF) or Speaker System - 6, Premium (RPO UZ6)
<b>Condition</b>	Some customers may comment on hearing a rattle or buzz noise from the IP during certain driving conditions, such as rough or dirt roads.
<b>Cause</b>	The cause of the condition may be that for particular radio speaker systems, there may be no speaker mounted in the center and/or right/left side positions in the IP. This may allow the push nuts that normally retain the speaker bolts to rattle when there is no speaker present in that location.

Verify the condition and install bolts to the appropriate IP locations to keep the push nuts stationary. The RPO UZ6 vehicles will require two bolts for the center position only, the RPO UQF vehicles will require six; two per three locations.
