Service Bulletin

Bulletin No.: 16-NA-339

Subject: Vibration Analysis Diagnostic Aids

Brand:	Model:	Model Year:		VIN:		Engine:	Transmission:
		from	to	from	to		
Cadillac	Escalade Models	2015	2018				
Chevrolet	Suburban						
	Tahoe						
GMC	Yukon Models

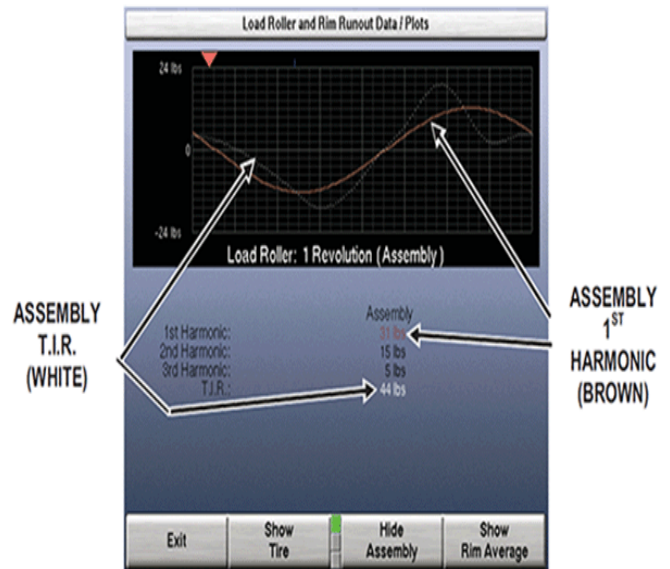
4743978

- Some cases of tire/wheel assemblies have been shown to have acceptable T1 RFV numbers, but with further investigation, have been found to have bent inboard rim flanges with hidden tire damage, visible inside the tire sidewall when dismounted.

Higher order RFV, T2 & T3 can be displayed in the Assembly Data Plots Screen, as shown above. Depending on the level of Road Force Balancer, the screen may be under 'Data' or 'Runout Plots,' then "Rim and Load Roller Runout Plots," or 'Road Force', 'Force Match', 'Data and Plots', 'Show Details.'

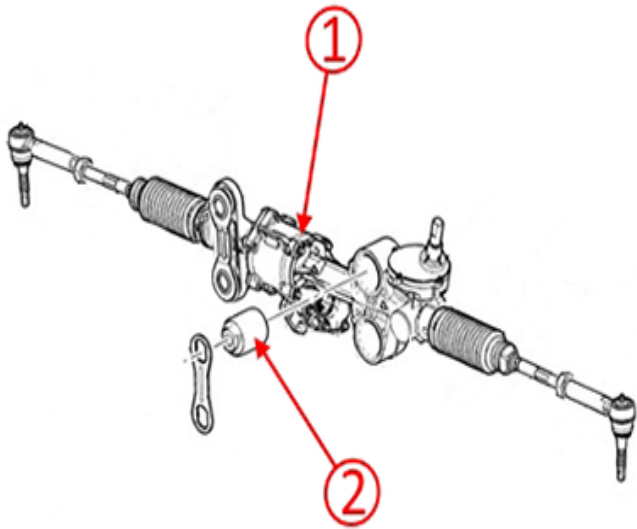
4743660

A revised steering gear/rack (1) mounting bushing (2) has been released to address customer vibration concerns. After various testing and measurement of T1 vibration, a vibration path from the tie rods =>steering rack=>steering bushings=>frame=>body mounts=>cabin floor=>seats has been identified. To help isolate the steering rack, a revised hydraulic mounting bushing has been released and tuned for the T1 frequency. The new steering rack bushing dampens minor T1 vibrations. It has been found that the new bushing also helps dampen minor T2 vibration / disturbance. This is the reason that the causal part (normally the Tire/Wheel Assembly) must be corrected first. If T1 vibration is over 20-25m/g's, the bushings will have little to no effect. Likewise, for T2 vibration / disturbance, the causal part/area must be corrected first to benefit from the bushings.

For vehicles with T1 vibrations under 20-25m/g's, replace steering rack bushings per parts catalogue. Refer to Steering Gear Mount Bushing Replacement in SI.

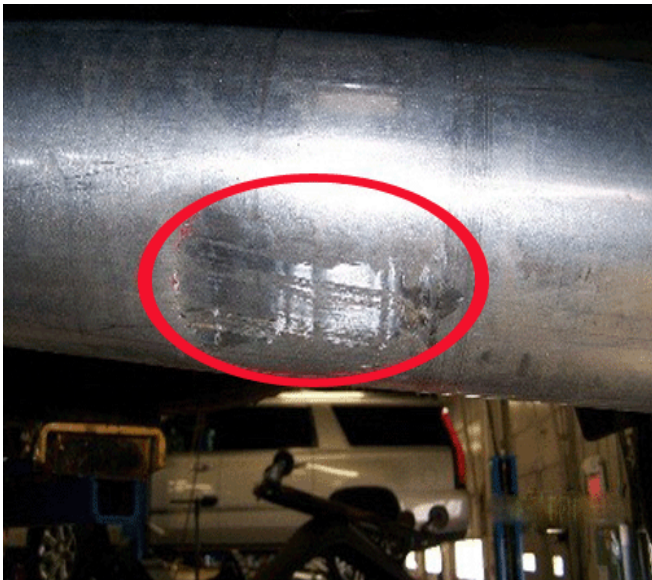
4002784

1. Inspect the propeller shaft for dents, damage, and missing weights. There have been many cases of dented propeller shafts. Damaged prop shafts must be replaced.

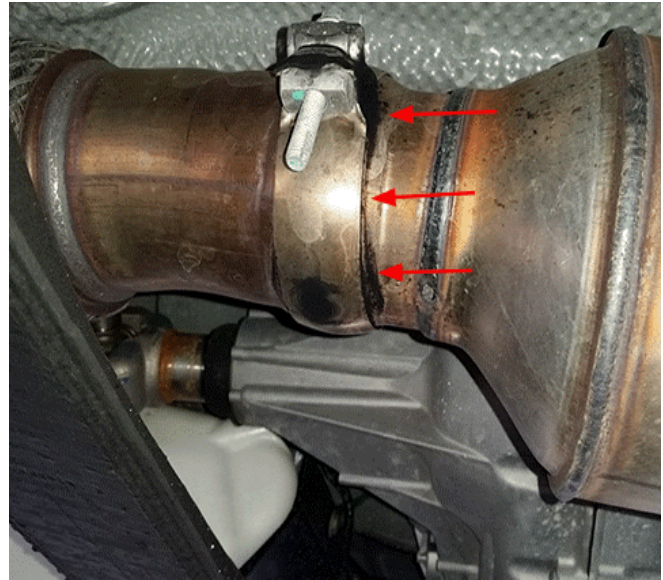
4743980

Note: There have been some cases of excessive V4 drone on 5.3L SUVs with the updated exhaust – a leak at the exhaust Norma clamp joint behind the rear converter may allow E2 V4 drone to manifest. 6.2L engines with a leak at the same exhaust clamp joint may allow excessive drone – more than comparable vehicles. Refer to latest version of PIP5442.
