Service Bulletin

Bulletin No.: 16-NA-405

Subject: Poor Engine Performance in Extremely Cold Weather Conditions, PCV Bypass Hose and Charge Air Cooler Icing for LUV Engines, Malfunction Indicator Lamp (MIL) Illuminated - DTC P0299, P0236, P2227, P00C7 Set

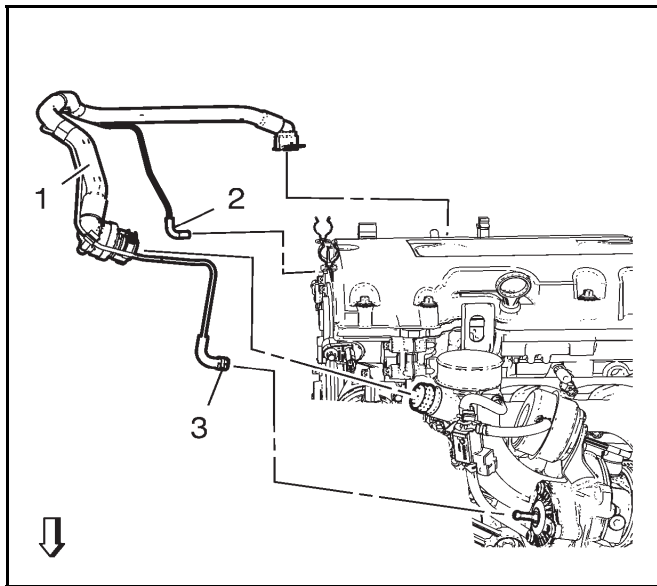
2191937

Note: Original PCV pipe with vacuum line attached removed from vehicle for illustrative purposes **ONLY**.

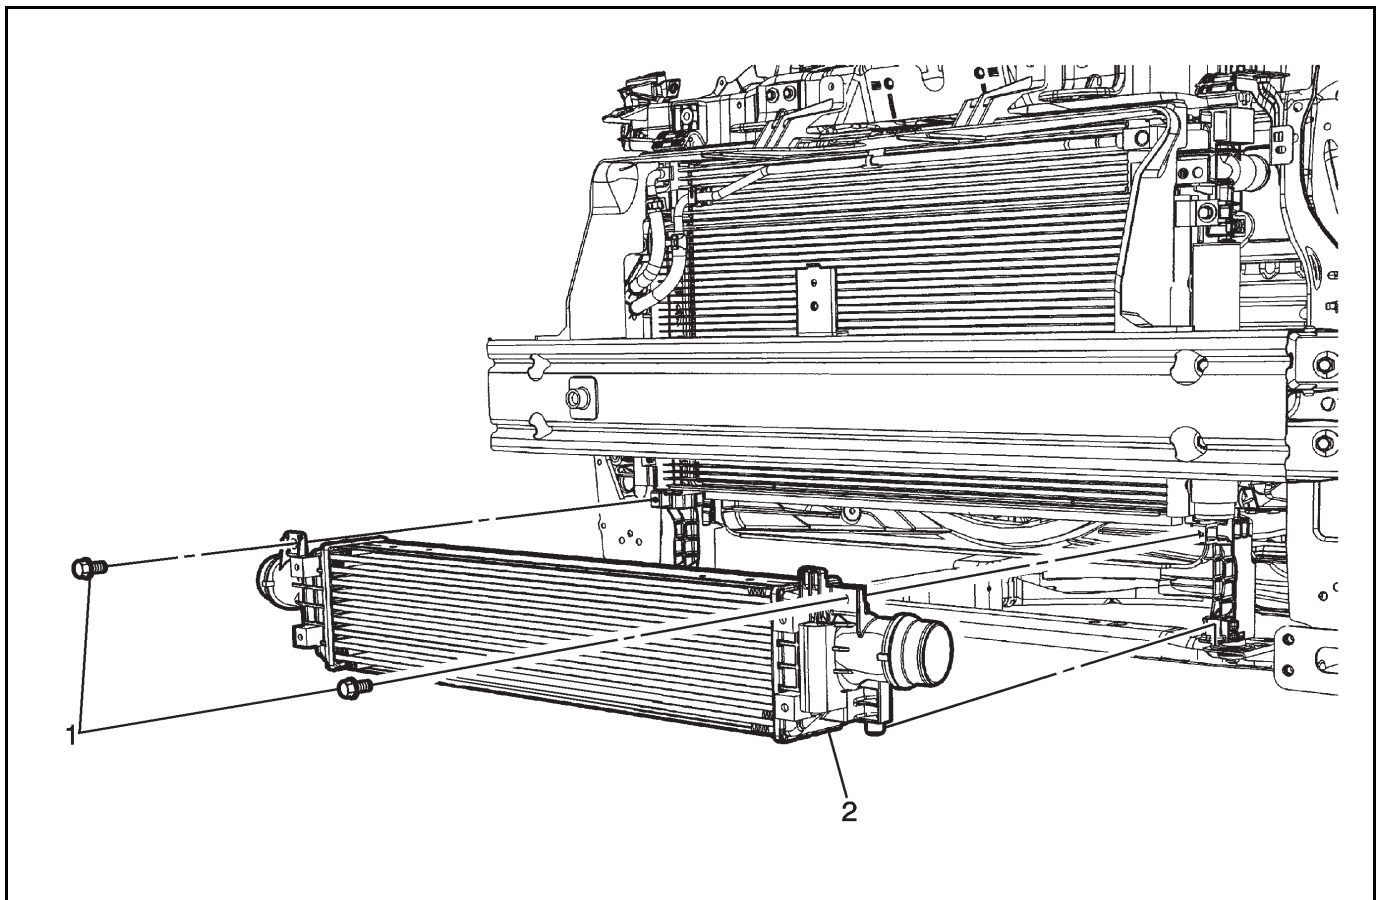
2851444

Note: Allow the Charge Air Cooler to warm up to room temperature so that any moisture can be drained.

38. Remove the CAC (2). Refer to *Charge Air Cooler Replacement* in SI.

39. Install modified CAC.
