Service Bulletin

Bulletin No.: 17-NA-074

Subject: Tips for Customers Having Difficulty Launching Android Auto or Apple CarPlay

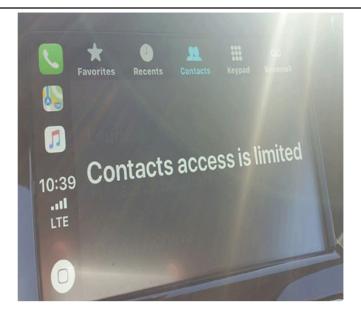
4925392

If the above "contacts access is limited" message is displayed, it may be a normal result of trying to access the contacts while in drive or while the vehicle is moving.

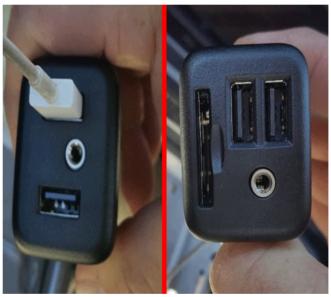
4747948

Note: Original Left Receptacle 2017 Silverado with Radio RPO IOB (Correct), Replacement Right Receptacle 2017 Silverado with Radio RPO IOB (Incorrect).

Ask the dealership to verify that the correct USB receptacle/hub was installed if this started happening right after they replaced the USB receptacle/hub for another complaint like the example above that shows a 2017 Silverado with radio RPO IOB that recently had the incorrect USB receptacle/hub (receptacle shown on the right) installed during service for a non related concern.

Note: To ensure the correct receptacle is installed, cross-reference the part number on the receptacle with the Electronic Parts Catalog all while using the VIN filter feature within the EPC.
